Risk Improvement Recommendations Update Report

Centro de Refinación Paraguana
Estado Falcón
Venezuela

Recommendations Update Visit Made: March 5th-8th 2012
Prepared on behalf of

Ref.2012/139

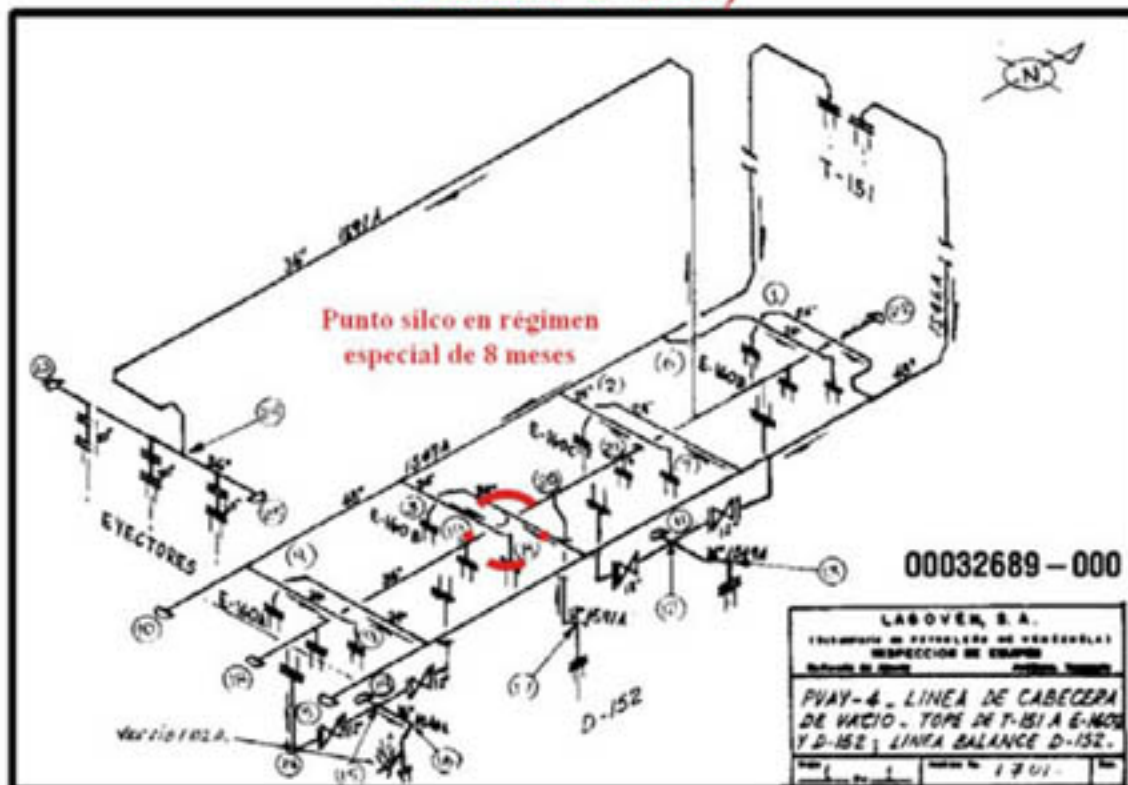
LINEA DE CABECERA DE VACIO (TOPE DE LA T-151)

A second line requested was the overhead line for the same vessel. This is a negative pressure line, and is fitted with stiffening hoops and support clamps. Initially there were about 20 inspection points, but these had been reduced to 5 based on operational and corrosion experience. The other points, presently "Inactive" in "SILCO®" do however have some historic readings, and could be reactivated. Point 8, an elbow, had been measured in 1986, 88, 91, 93, 95, 98, 2000, 01, 04, 08 and twice in 2011. The graph presented shows little loss in wall thickness up to 1998, then a significant loss in the period 1998 to 2000, followed by a continued slow reduction. The remaining life for the five points measured varied from a maximum of 15 years, to a minimum of 1.6 years (for Point 8), and it's inspection interval has been reduced to 8 months. We would question whether this finding should have justified the reactivation of "inactive" inspection points on this circuit? (See illustrations below) These and other lines are due for replacement in the 2013 turn-around.

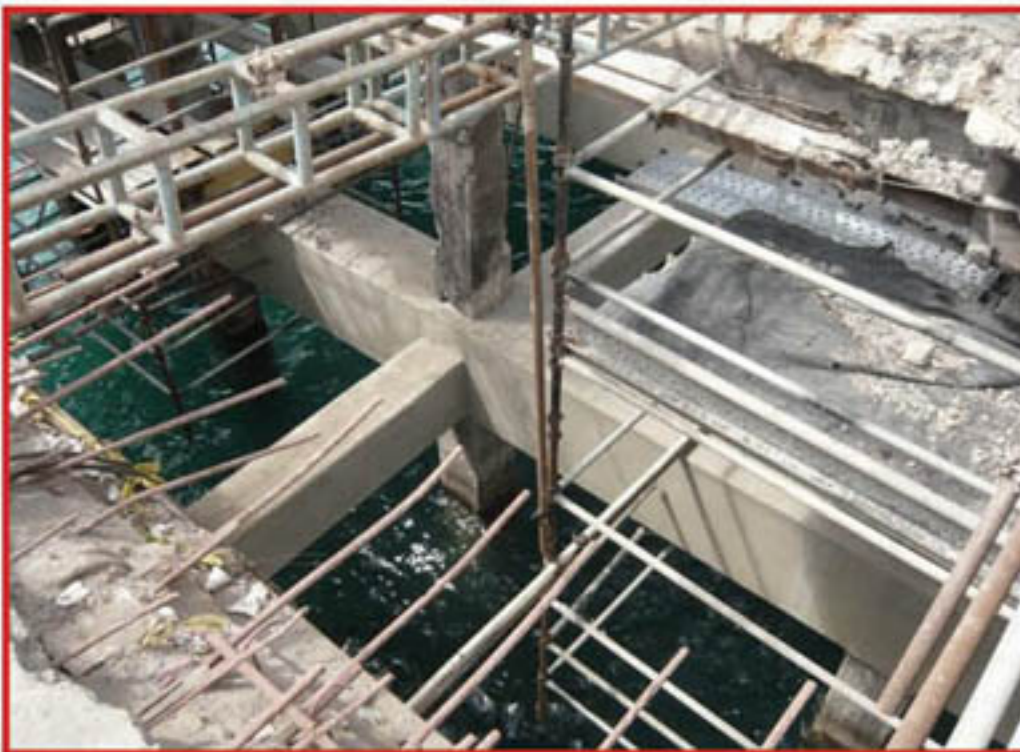
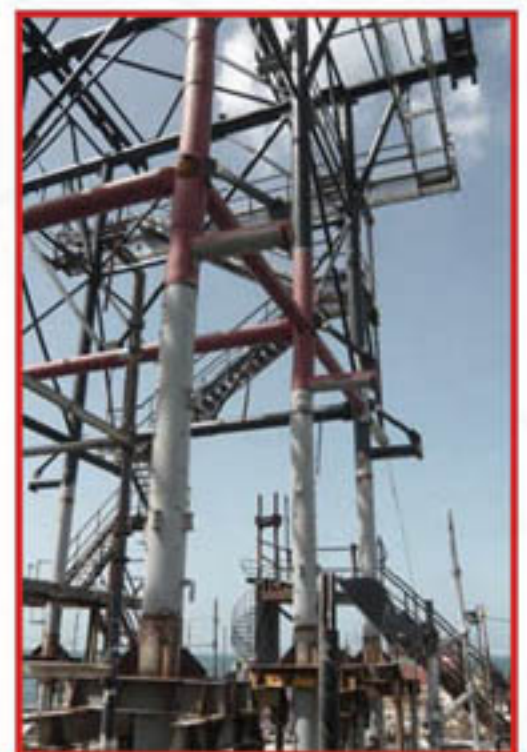
The Jetty 1 refurbishment features a reduced number of hose connections. (More Photos in "Observations" below)

<<Shows extent of repairs to jetty sub-structure.

And replacement of top-works, hose gantries etc.>>

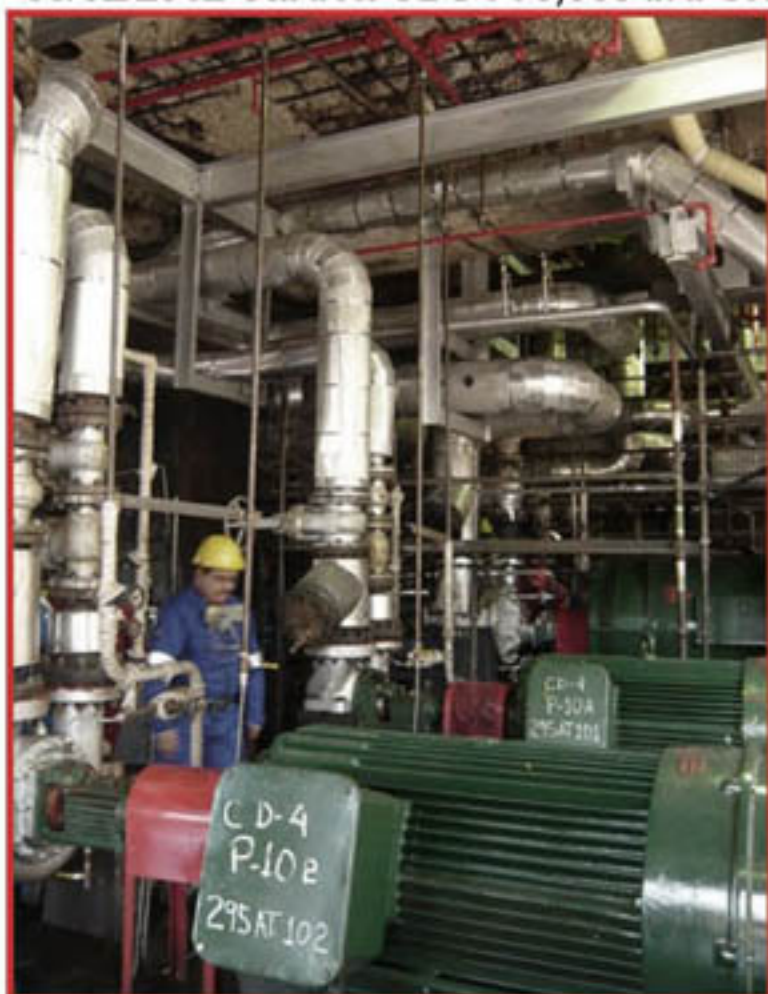
05/02/2012 Cardon CDU4 70,000 b/d Crude Distillation Unit Fire.

<<Column Bottoms Pumps suction line small bore drainage connection failed. Subsequent fire caused significant damage to unit, Remains out of action, Emergency Isolation Valves being installed as part of repairs – if installed sooner would have reduced the consequences. Note damage to underside of second level floor

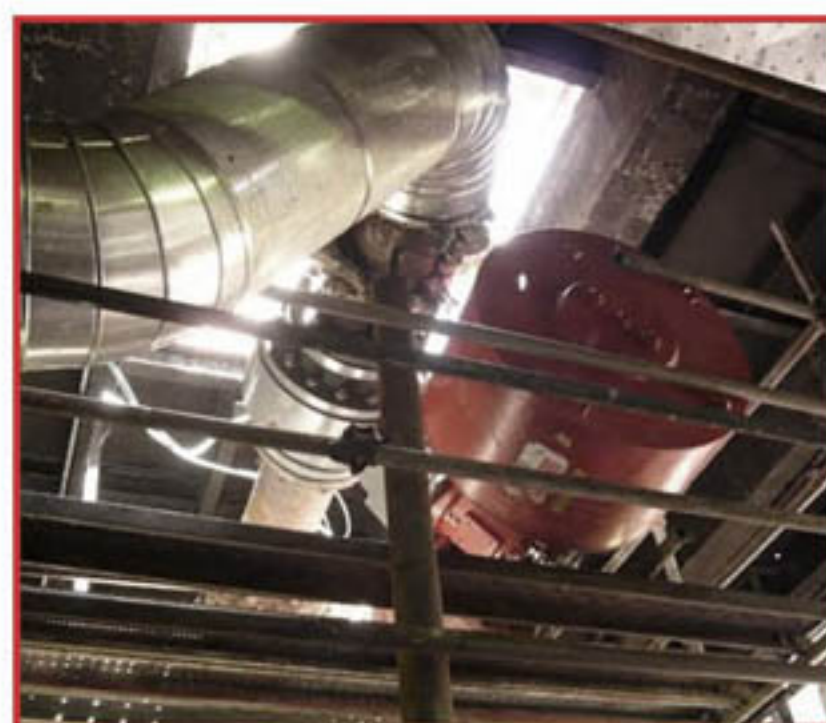
One of the new EIVs

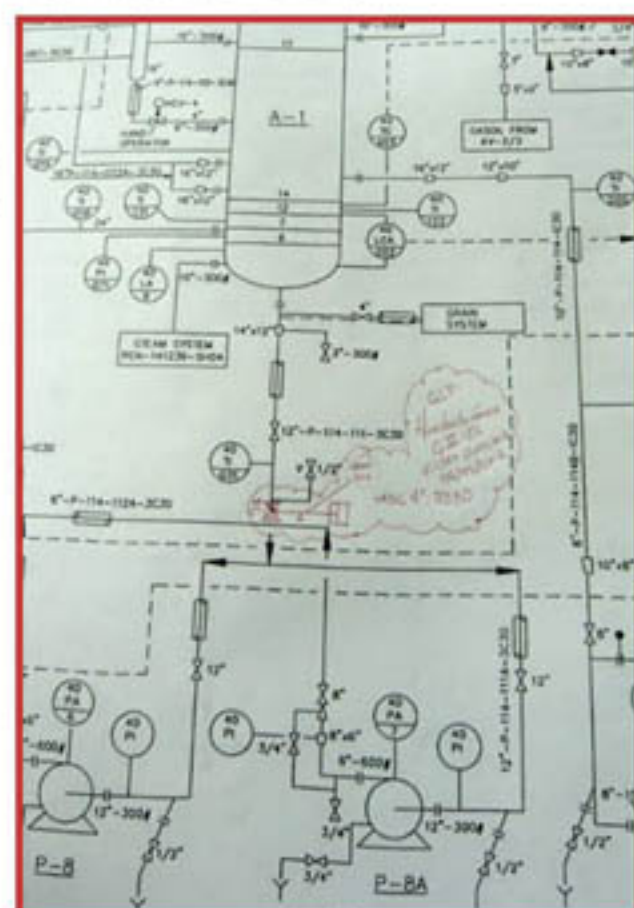
As shown on the "redline" P&ID. Note date of "redline".

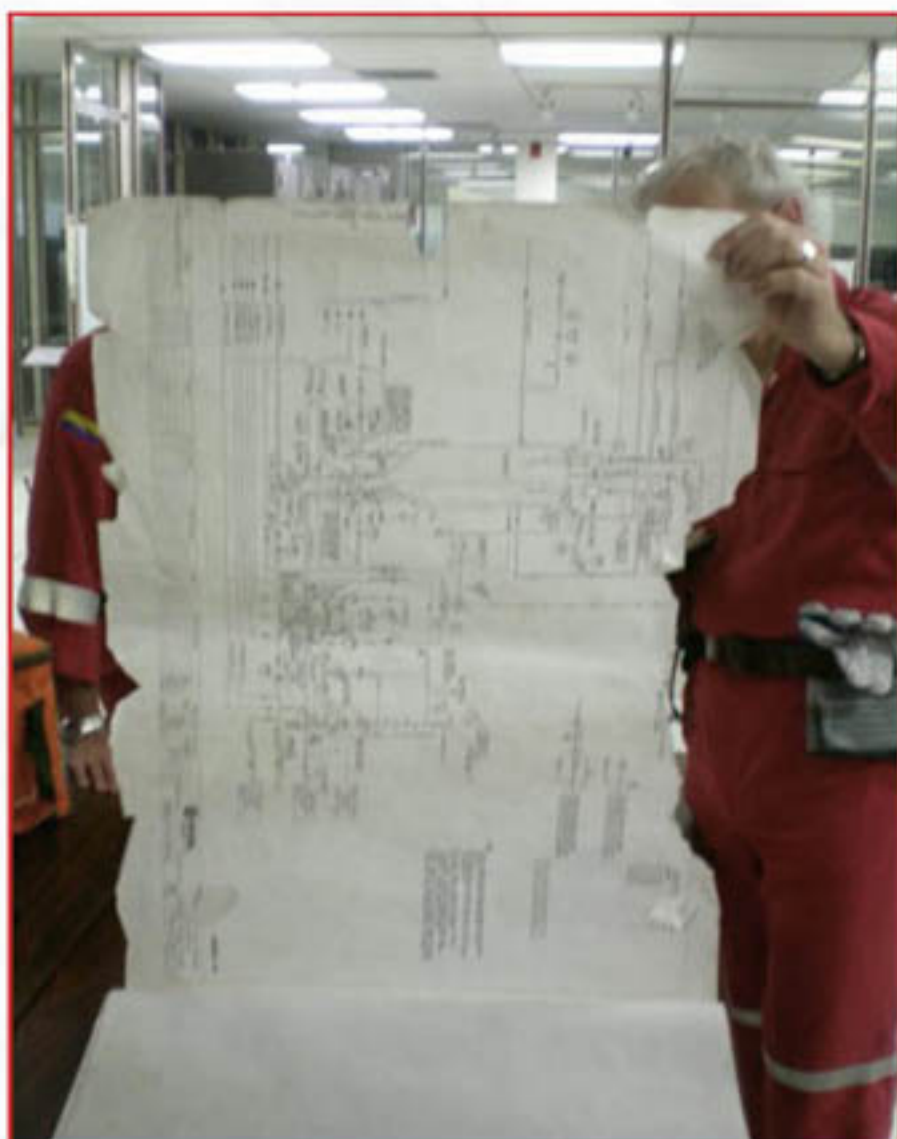
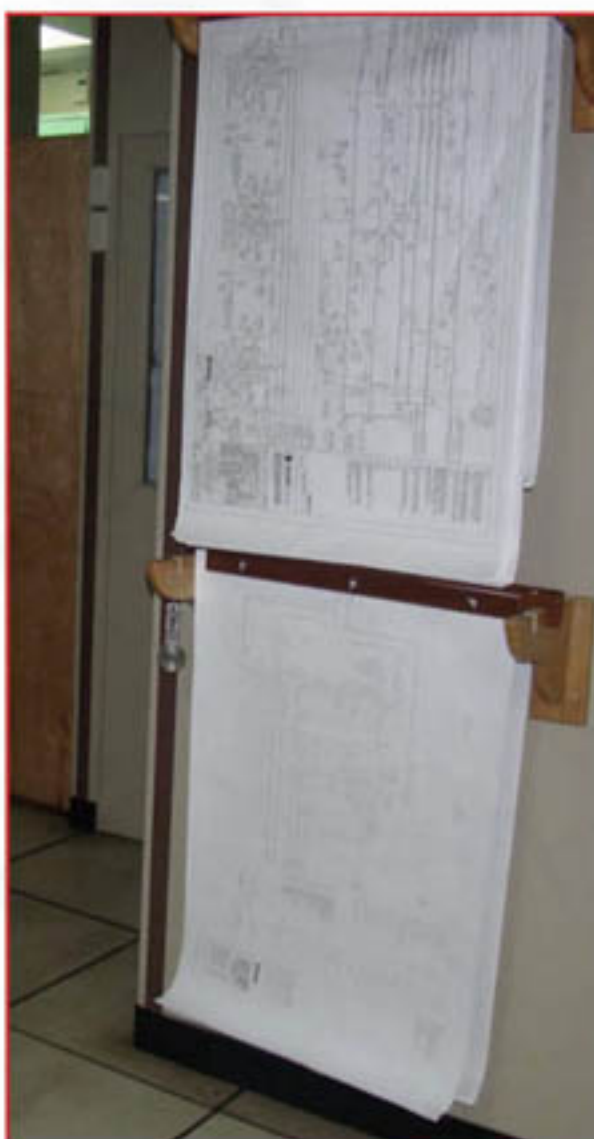
The condition of some "master" drawings on stick-files was questionable (left), although we have been shown "actualised" drawings, properly approved (centre and right).

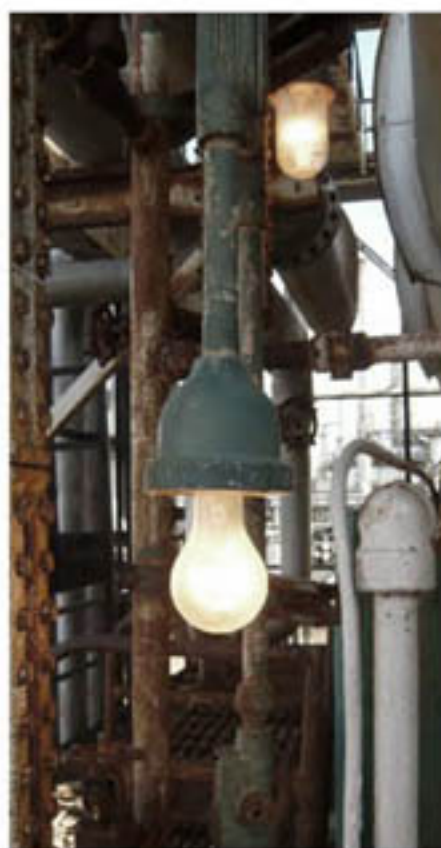
Still below standard at Amuay, but much improved on Cardón. Example below from Amuay.

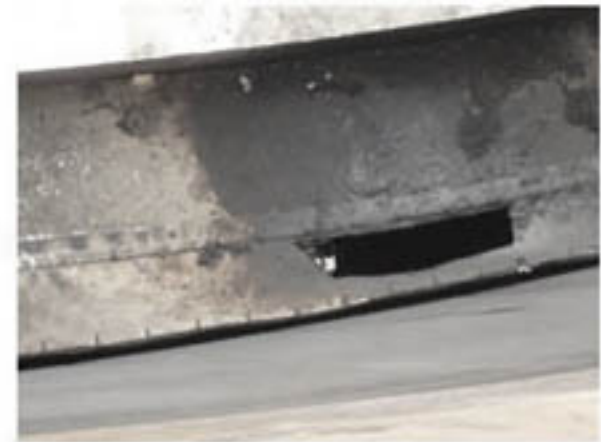
Tank seen (A7.2), Lagomar 5 Light Crude, holes in weather seal, gaps between wall and seal, roof seal flooded. (See photo)

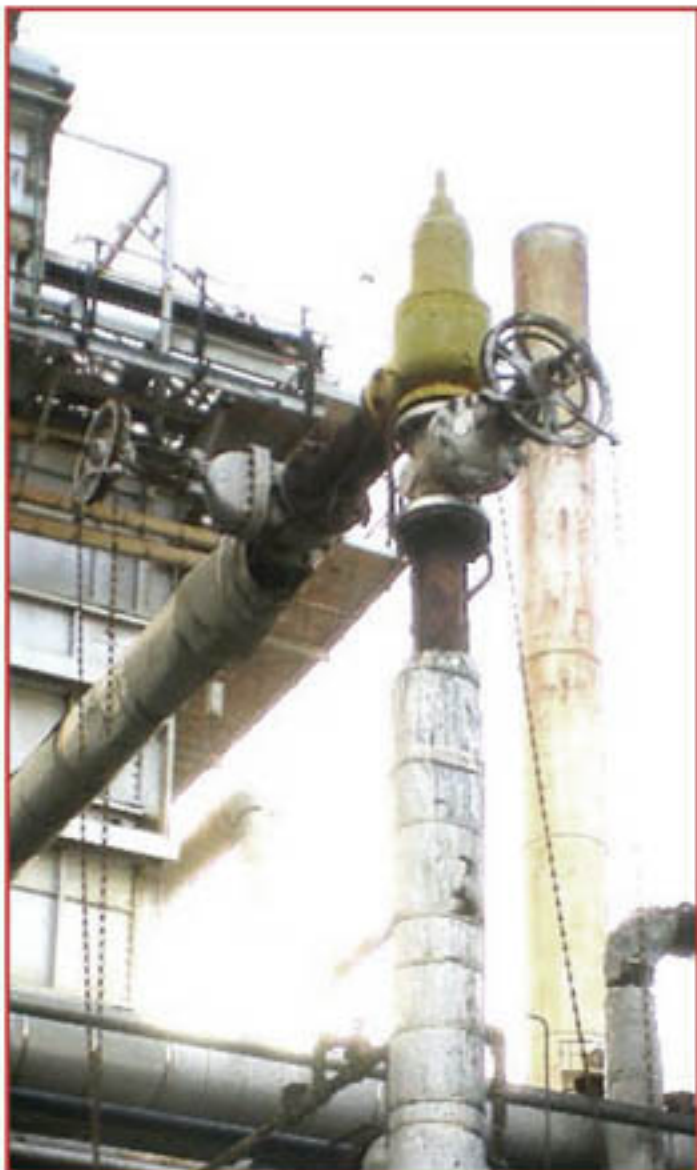
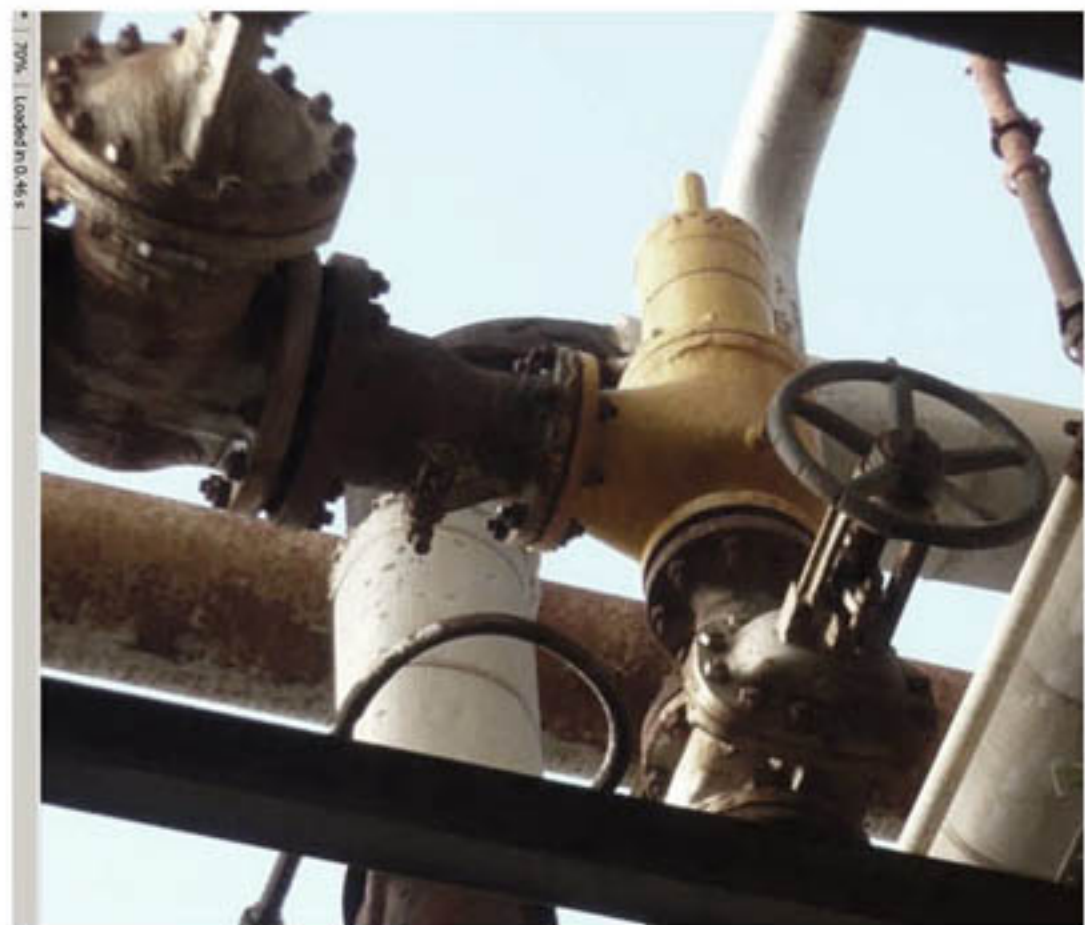
Still an inconsistent approach

Some valves seen controlled using cable ties, however many others seen not to be controlled.

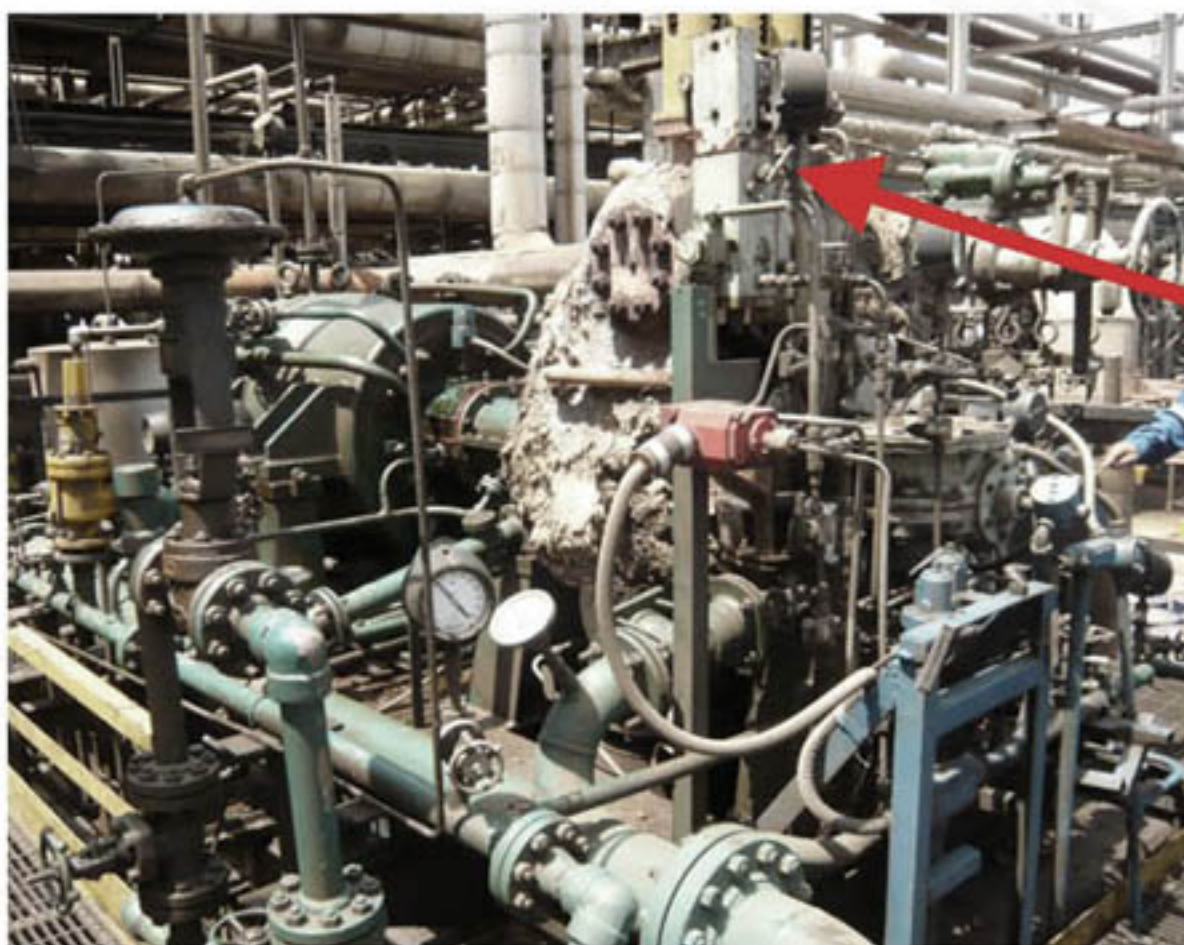
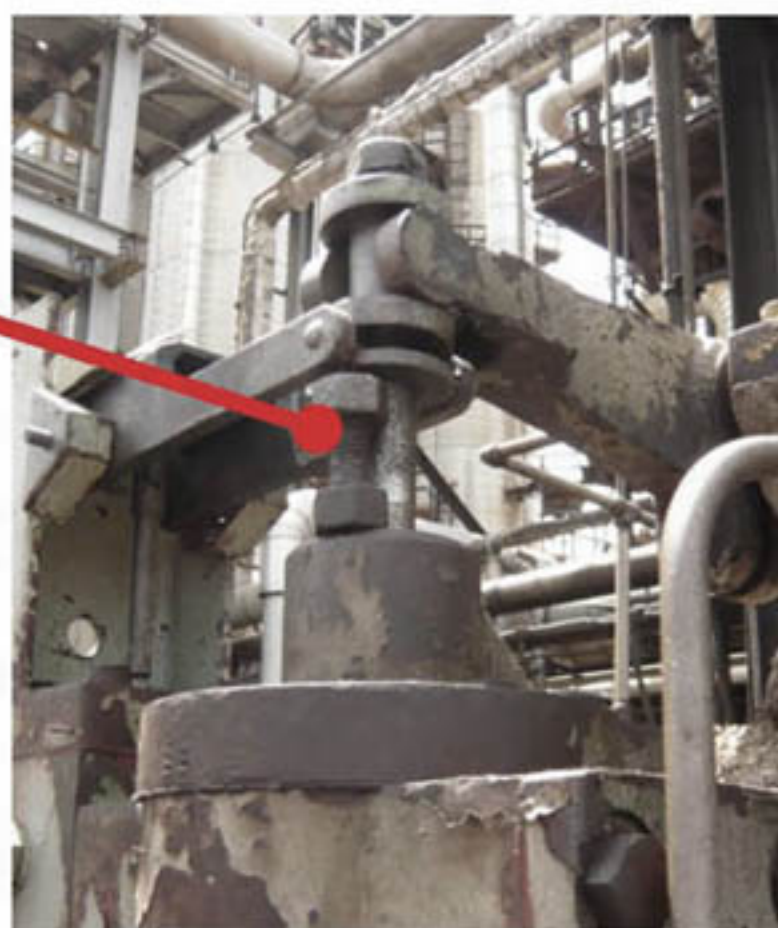
At the time of the visit, the physical block had been left in situ, but the bypass was not recorded in the Bypass Register, and as far as we could make out was implemented without any approval. Also, the Permit-To-Work (PTW) documenting the last repair during which such unorthodox bypass was applied could not be found and staff recognized that, in the end, no PTW had been issued.

We Recommend:

- 1 To conscientiously rectify in the field the above described anomaly.
- 2 That no protective system bypass **of any kind** should be permitted without the appropriate assessment and approval, recording of the reason for the bypass, its time of application, time of removals etc, as required by the bypass register book and bypass control procedure. This must apply to software, key switch, hand-switch, jumper wiring, physical blocks, valve movements, wedges, or any other means whereby a system in whole or part is disabled.
- 3 That regular site audits be carried out to identify and correct any deviations from proper implementation of the bypass procedure and that personnel involved in such audits must be briefed on what to look out for in discovering unauthorised or unconventional bypassing activity.

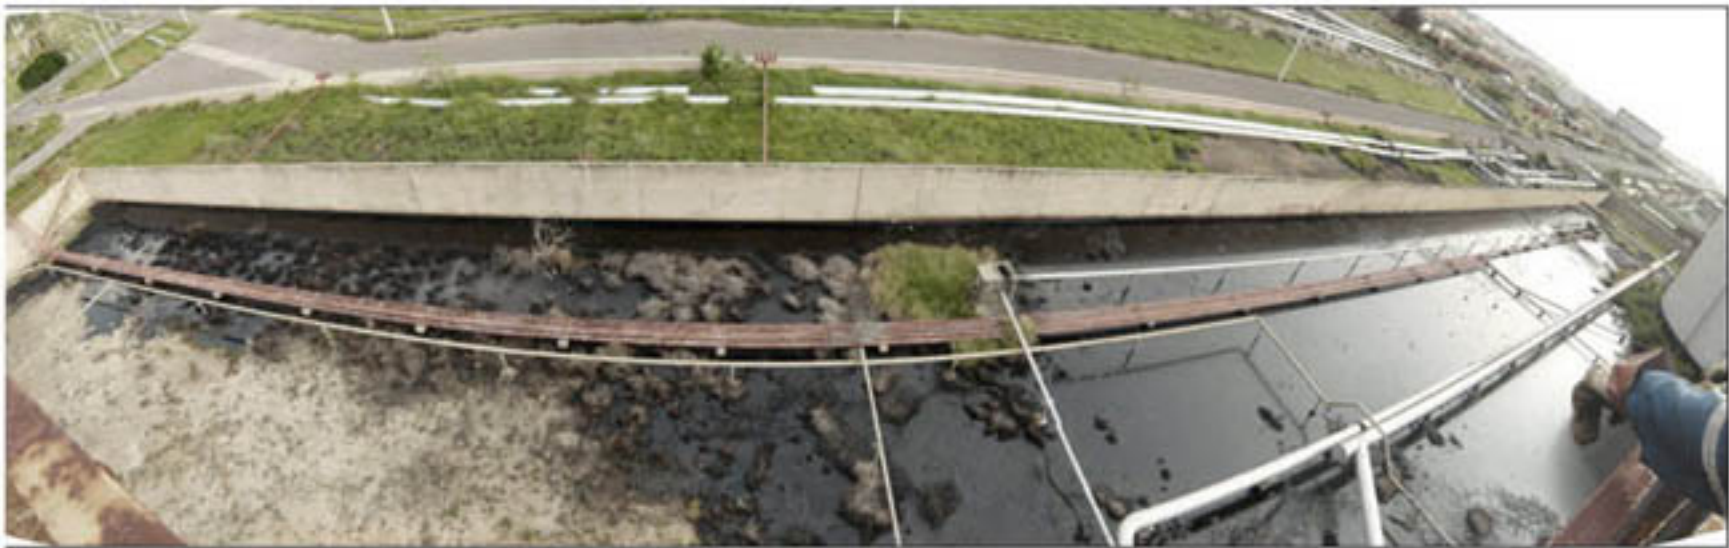
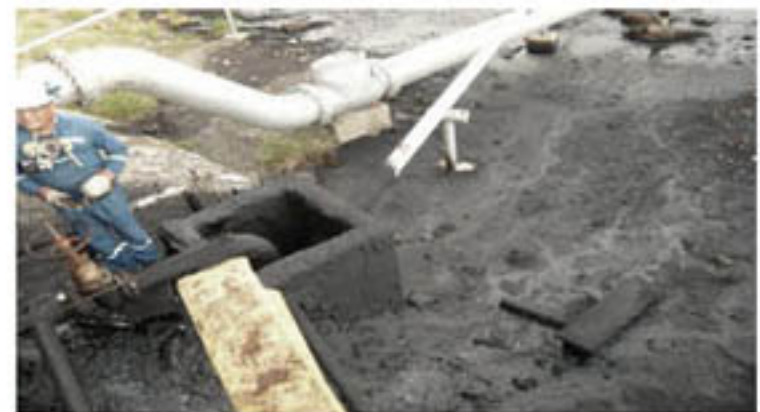
During the survey it was noted that there was considerable contamination in tank A7-2 (Cardon) with crude oil and water, originating from the tank water draw.

The reason given for this was associated with the piping system to the oily drain. It is apparent that the situation has persisted for a considerable time.

This constitutes a significant fire risk, noting that crude oil pipework and the floating roof seal pipework runs above ground in the contaminated area.

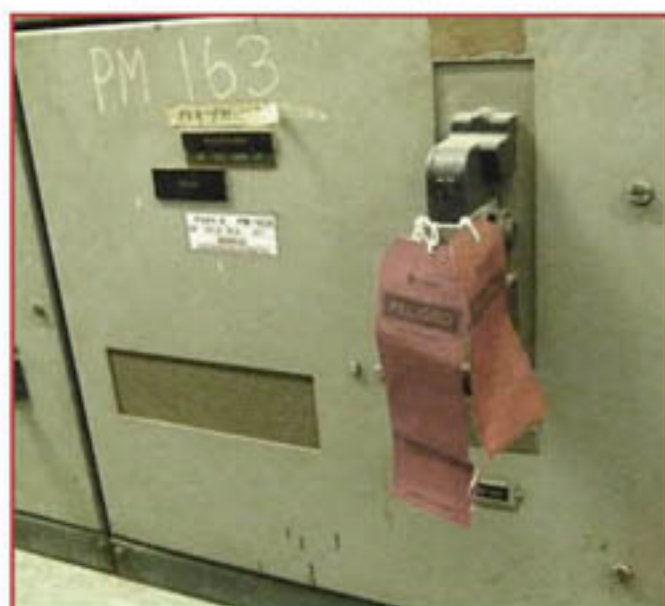
Full LOTO is not in practice. Dupont Training "Best Practice" has been taught, but is not practiced. The PDVSA Norm also calls for full LOTO.

Breaker with tags only

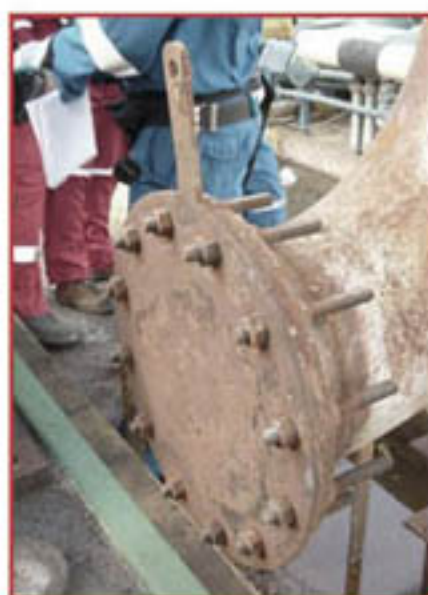
Pump Discharge – plate used instead of blind flange

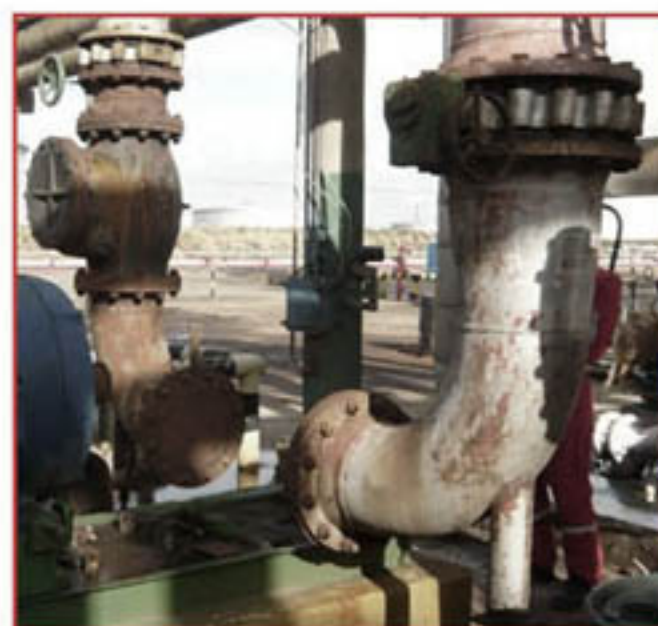
Same pump – valves not tagged or locked.

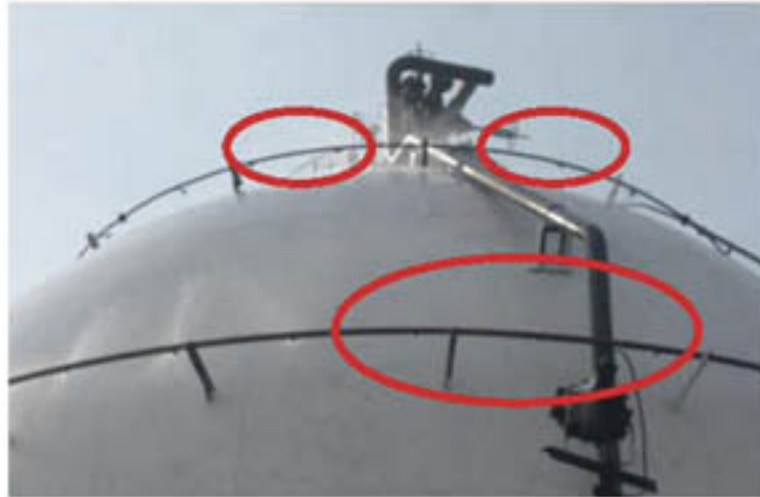
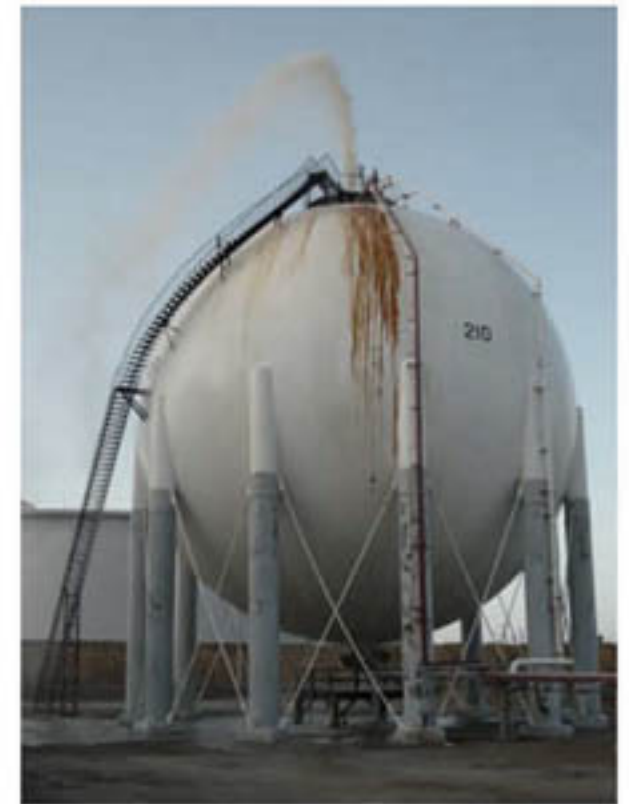
A test of the deluge on Spheres E-01 & E-02 at Cardón revealed some blocked nozzles and some nozzles not properly pointing at the sphere, although the overall cover of deluge water appeared to be adequate. (see photo below)

These are the only deluges for which we requested demonstrations, and defects were noted in each case (although rather minor in the Cardón test case).

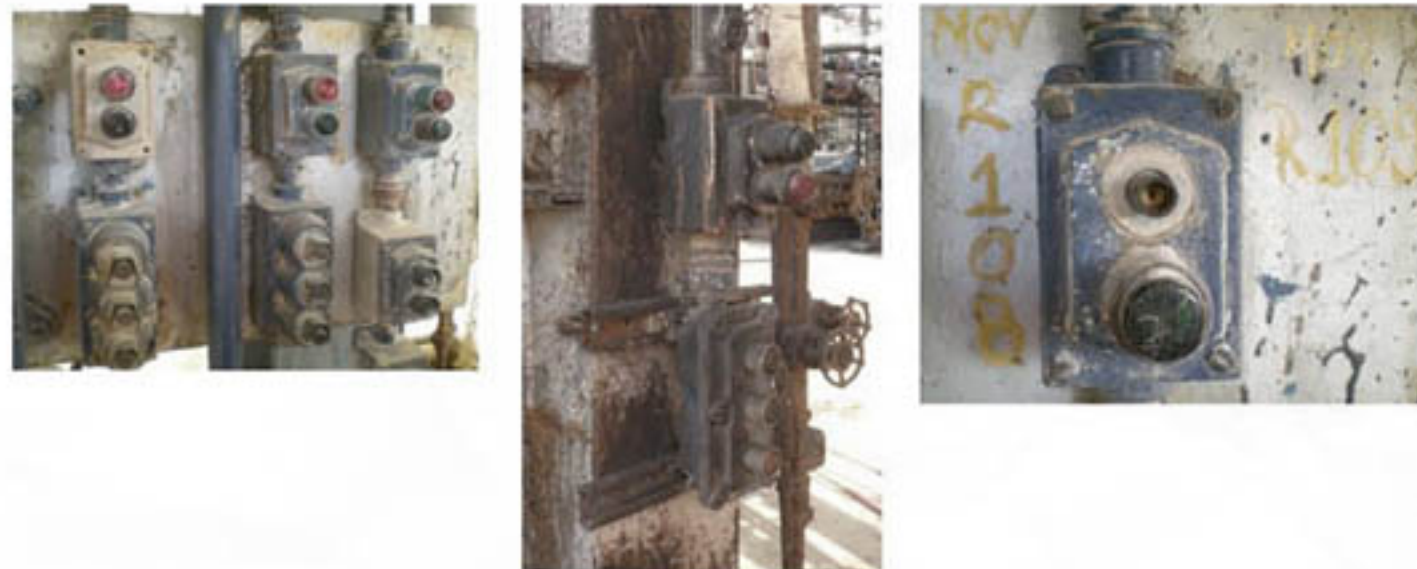
In our opinion these critical protection devices might be difficult to locate in an emergency, and once located, the appropriate pushbutton might not be immediately apparent (see photographs below)

We Recommend:

- 1 The safe location of EIV pushbutton stations be reviewed in the context of risk from process incidents.
- 2 The EIV pushbutton stations be clearly designated, by means of conspicuous colouring of the concrete column on which they are located.
- 3 That each individual EIV pushbutton module be clearly identified by tag number and the equipment served by the EIV.
- 4 That all EIV pushbuttons be regularly tested and maintained in optimal operable conditions.

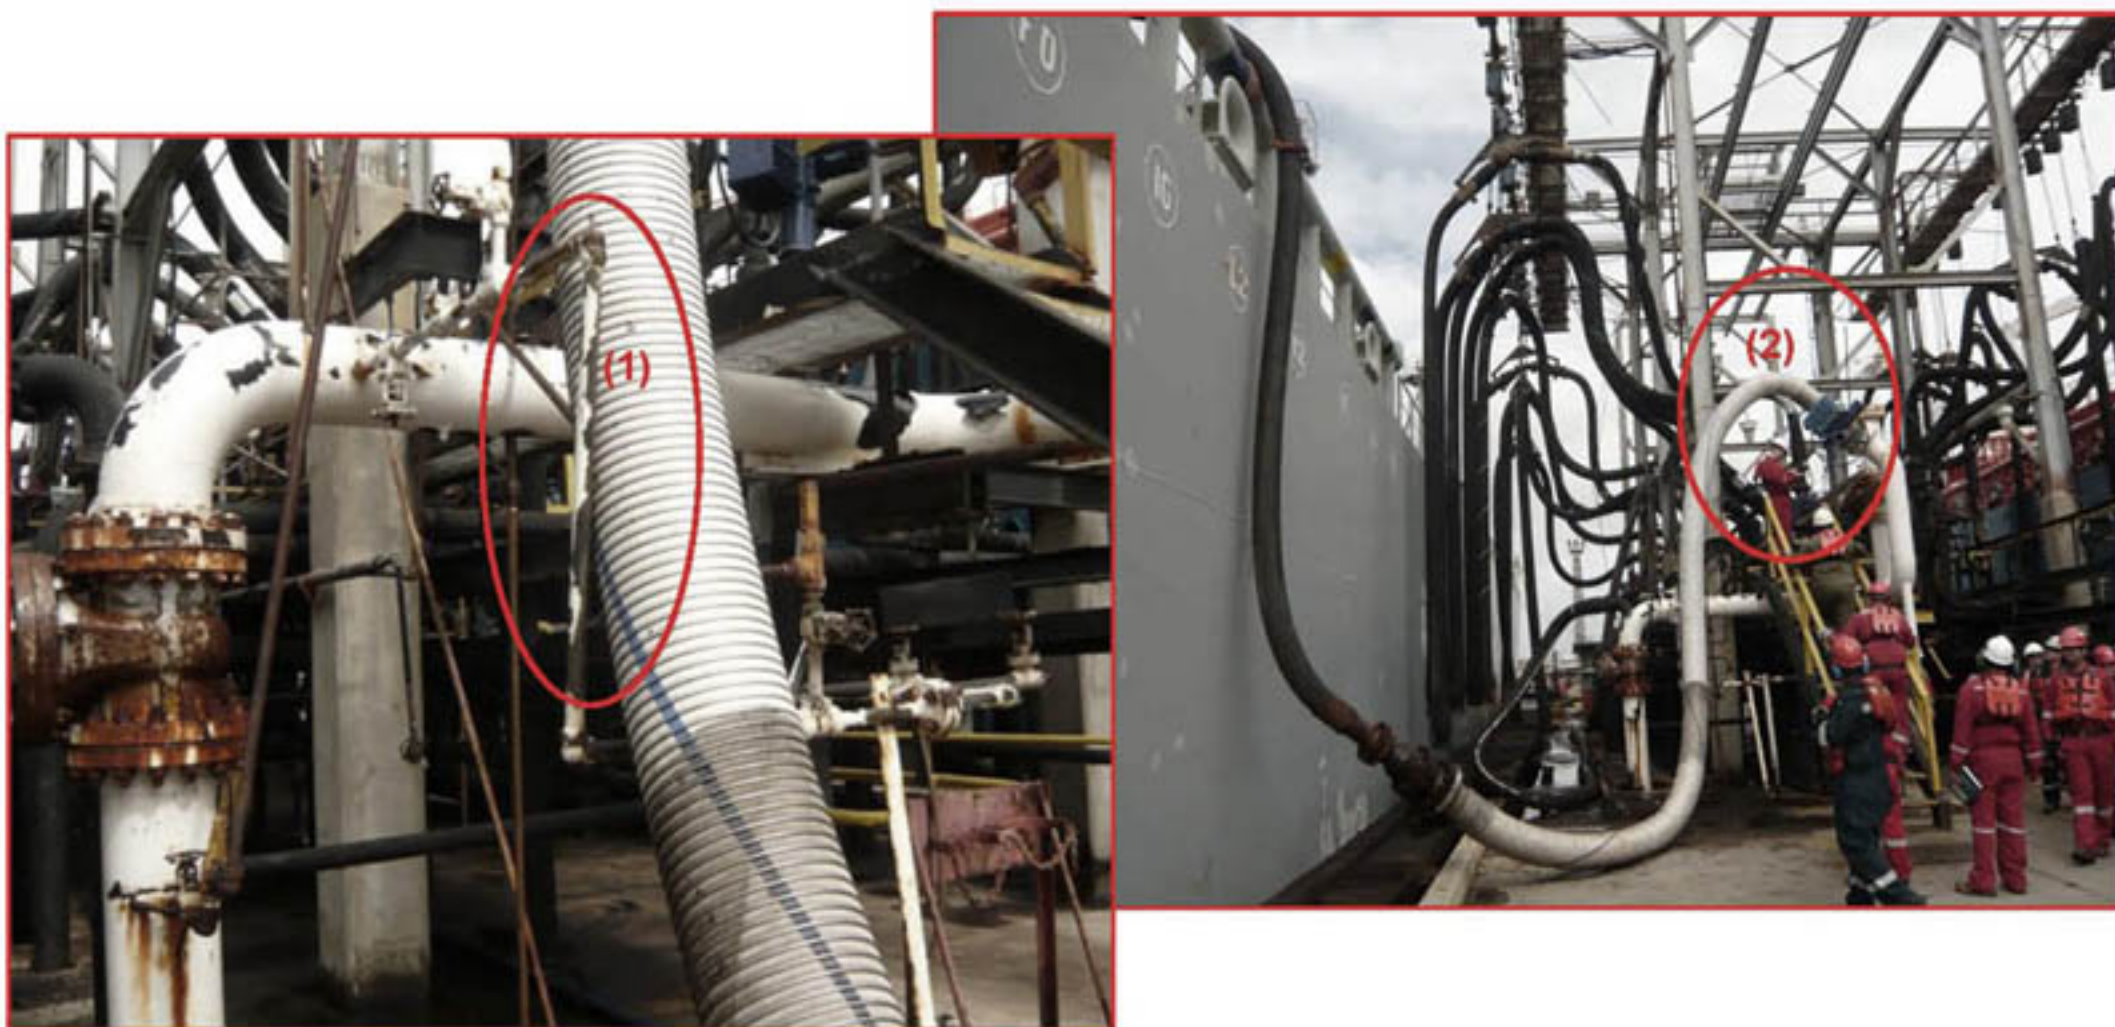
We noted an instance of a (heavy) hose bearing on a small bore relief line (1)— on LPG duty. (see below). This line serves both a thermal relief valve and a Nitrogen Purge point. It is also noted that this LPG line uses no hoist, and that there is an unsupported small radius bend, which must act as a significant stress raiser. (2)

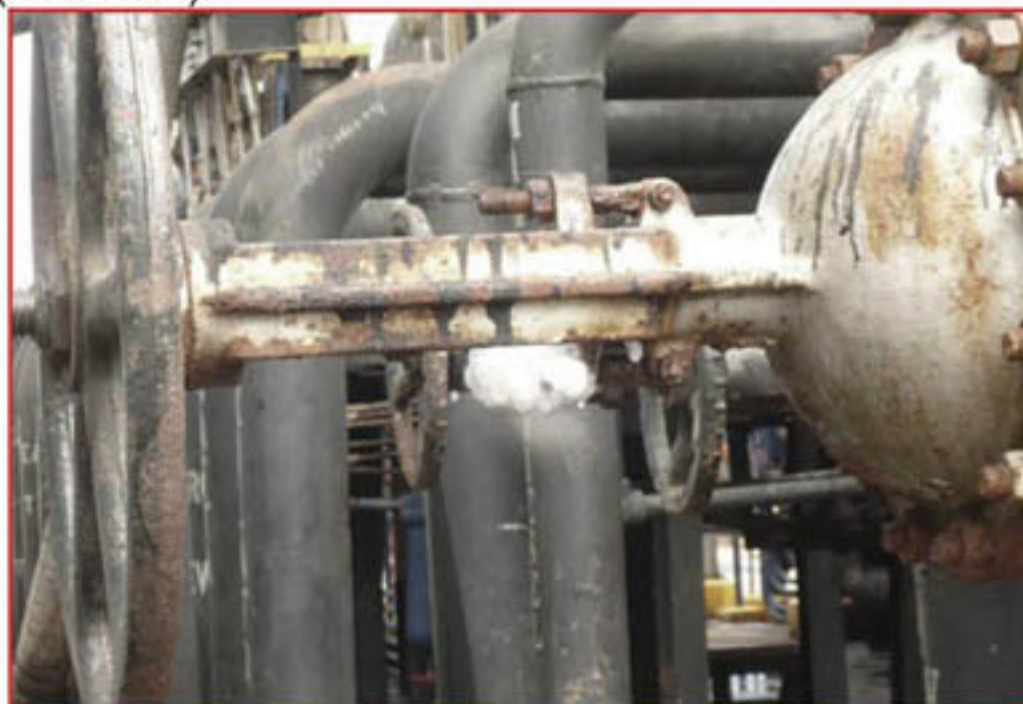
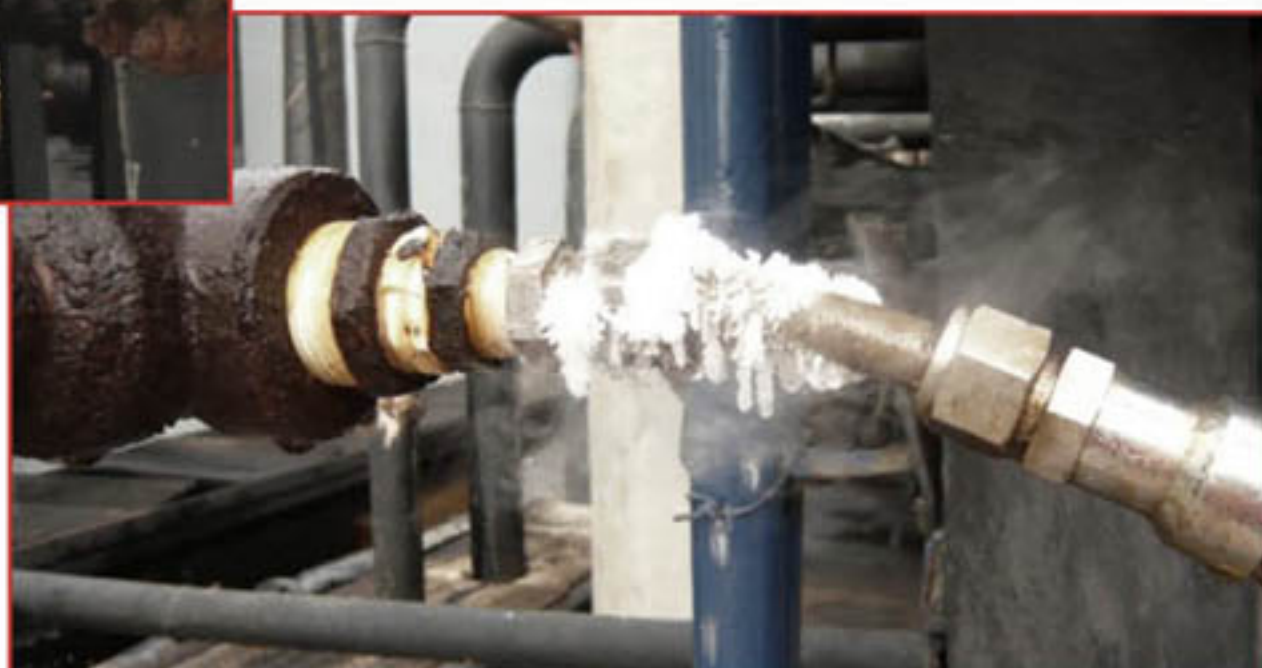
Two LPG leaks were also noted on the same system, one on the Nitrogen Purge Point, and one on a valve packing (see below).

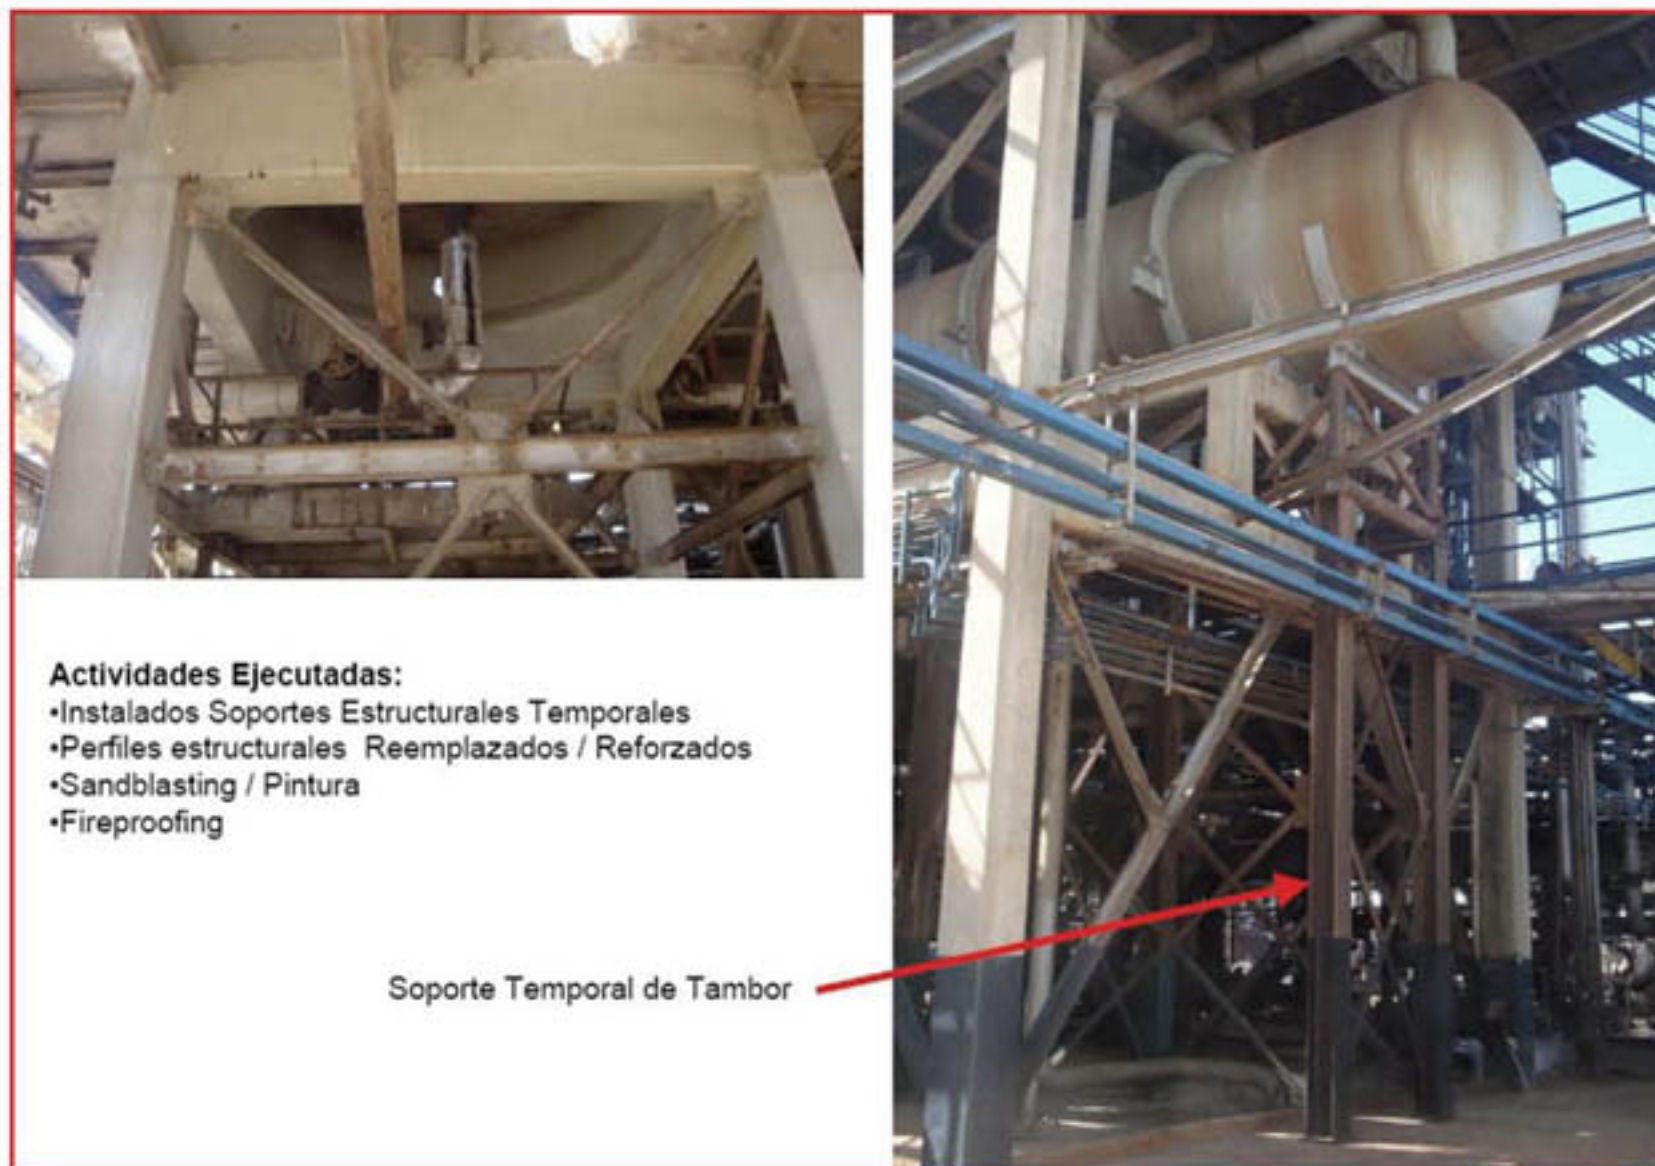
Structural Integrity Programme – good evidence of progress, but a long way to go.
These pictures from Amuay PS/PVAY1

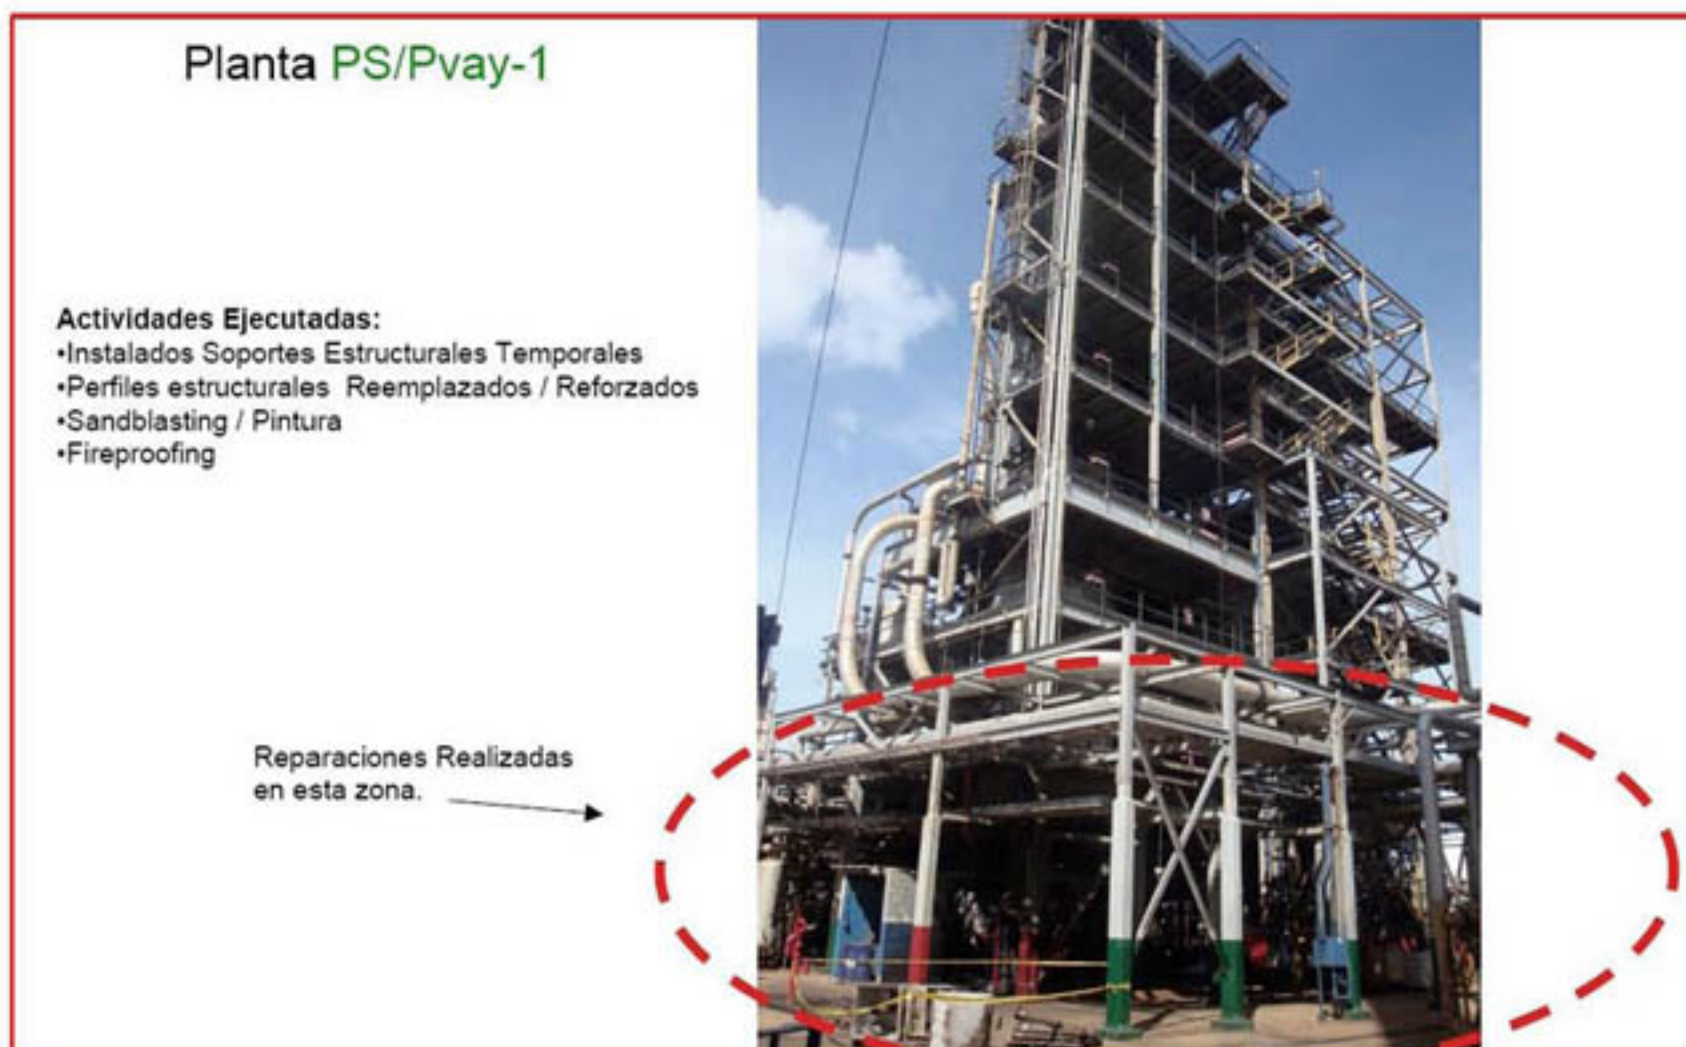
The "Soporte Temporal" was installed to allow operation to continue until the structure was renovated. Note that it was not fireproofed, hence the structure was not effectively protected against failure during a fire. The renovated structure restores the necessary fire-proofing. Note also that the repairs (temporary and renovations) were carried out as "SIMOPS" - i.e. on the run.
