Risk Improvement Recommendations Update Report

Centro de Refinación Paraguana
Estado Falcón
Venezuela

Recommendations Update Visit Made: March 5th-8th 2012
Prepared on behalf of

Ref.2012/139

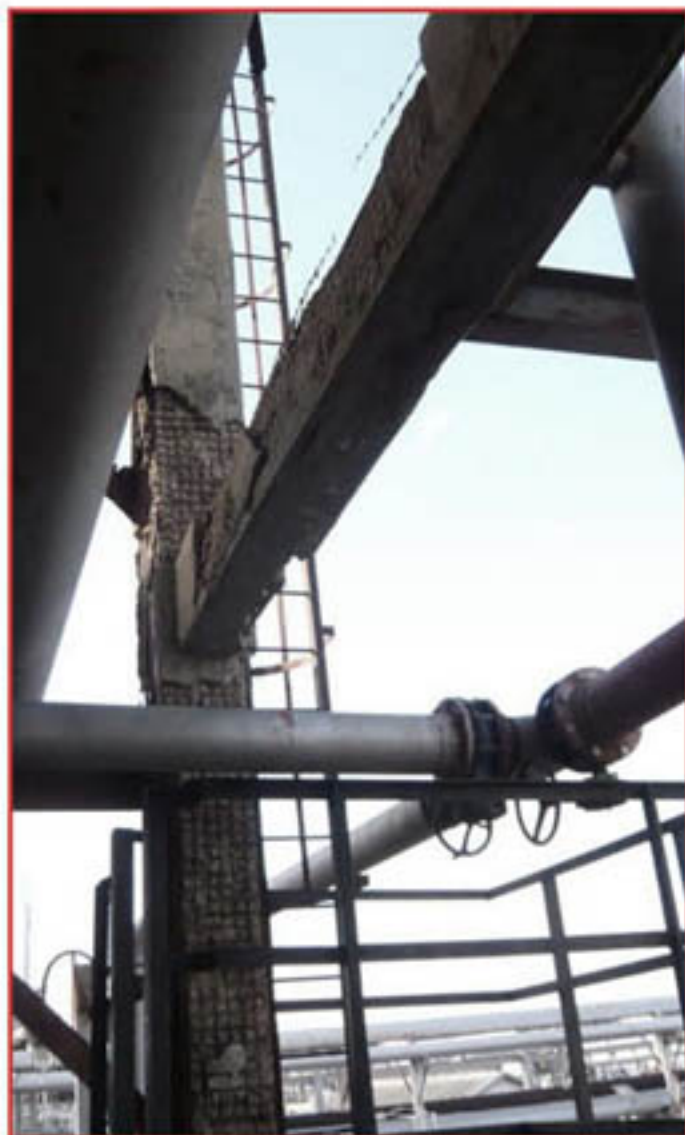
Much still to be done, especially at Amuay

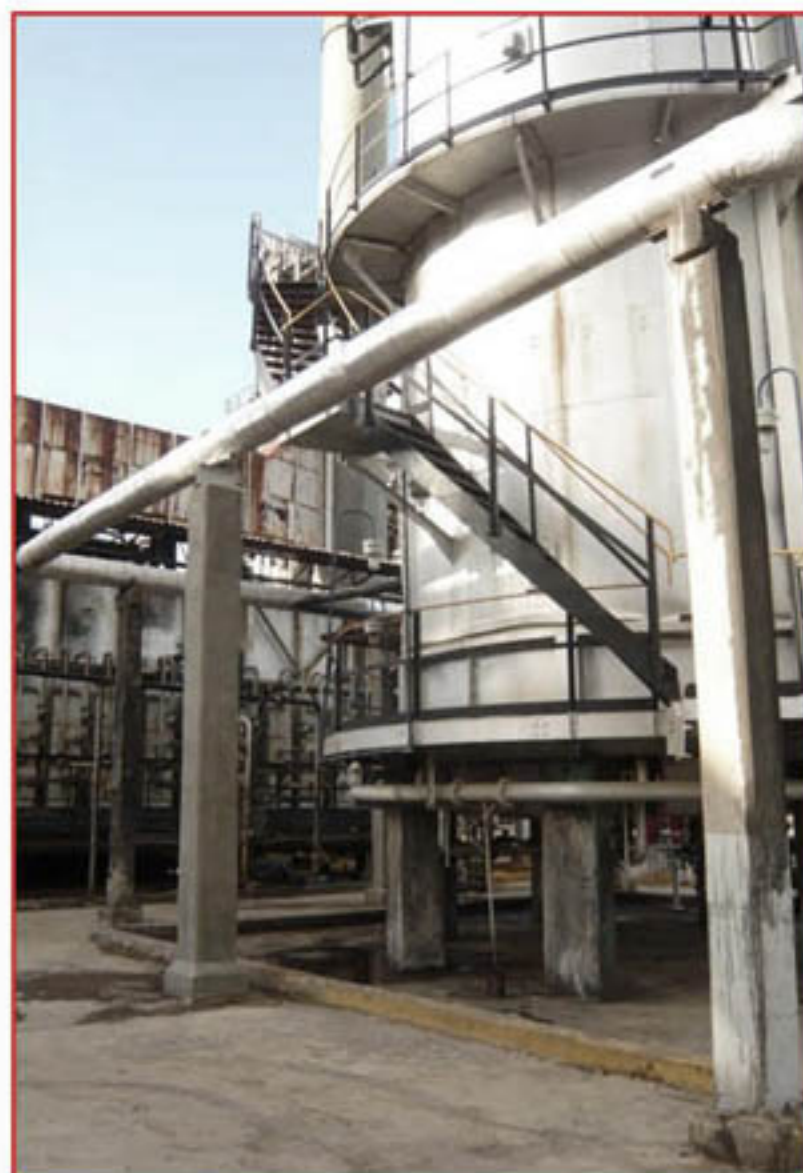
Structural Fireproofing on the structure of PSAY4, advanced degradation of structural fireproofing – to say nothing of the probable condition of the steelwork it encases.

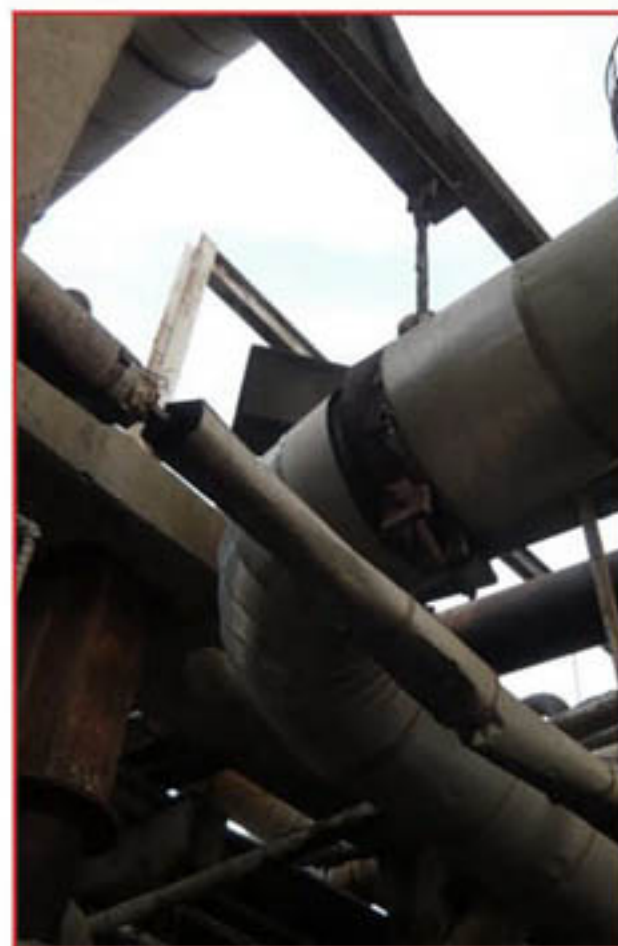
PVAY-4 Vacuum Unit, Compromised structural fire protection and temporary support in place pending repairs to structure.

Vacuum Bottoms Line – pipe hanger from unprotected beam, bolt on support clamp not secure, no catchbeam, and as yet, no EIV on column bottom.

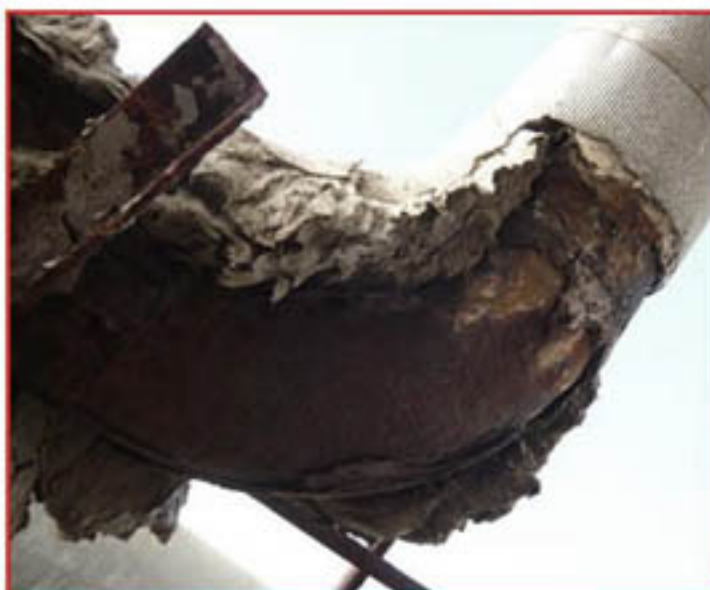
PVAY-4 Corrosion under Insulation There is a programme to remedy this.

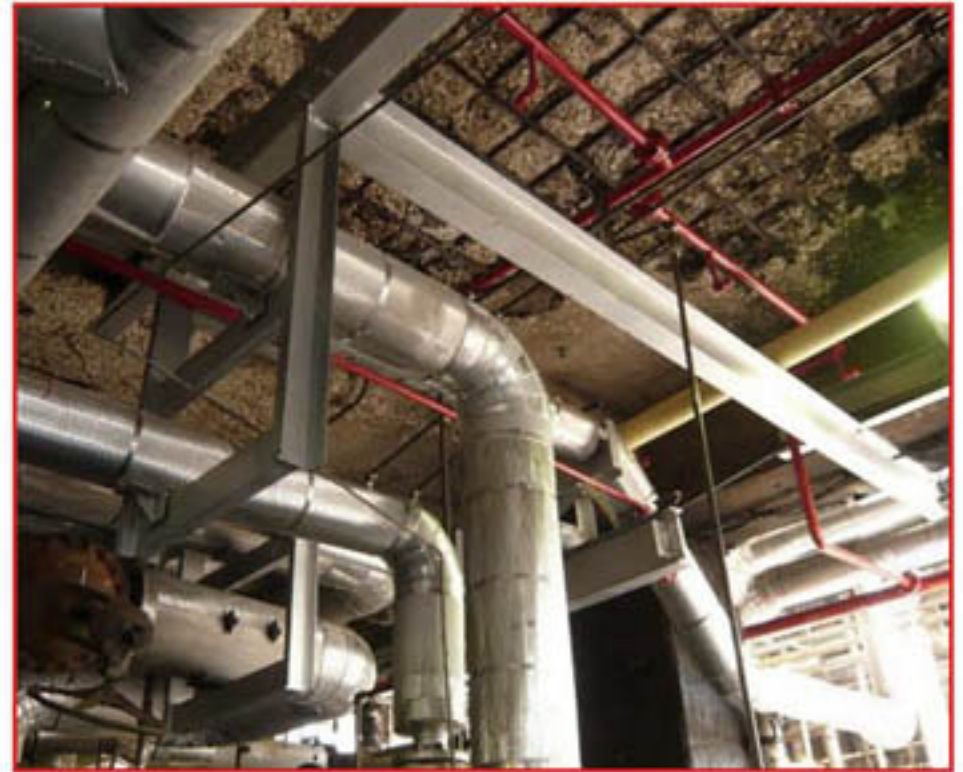
Highly congested and confined area of pumps, re-bars exposed by concrete spalling on underside of upper (exchanger) deck, not clear when (if) these are to be repaired.

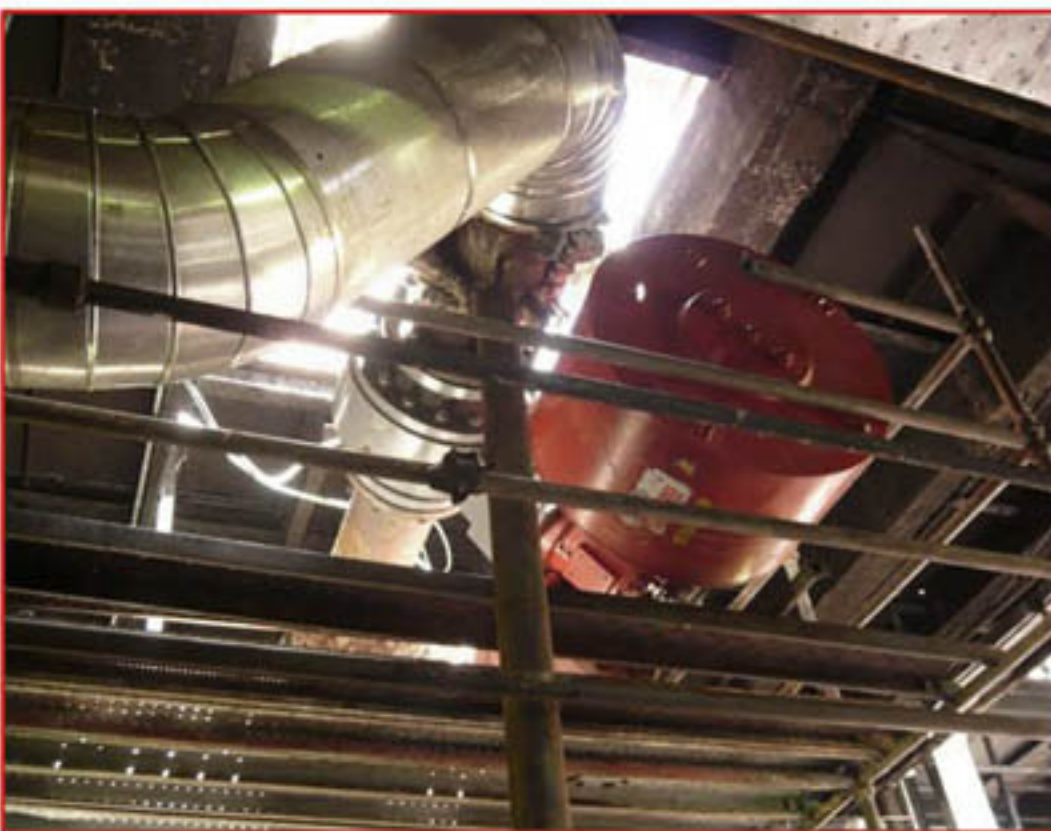
New pipe supports - not fireproofed.

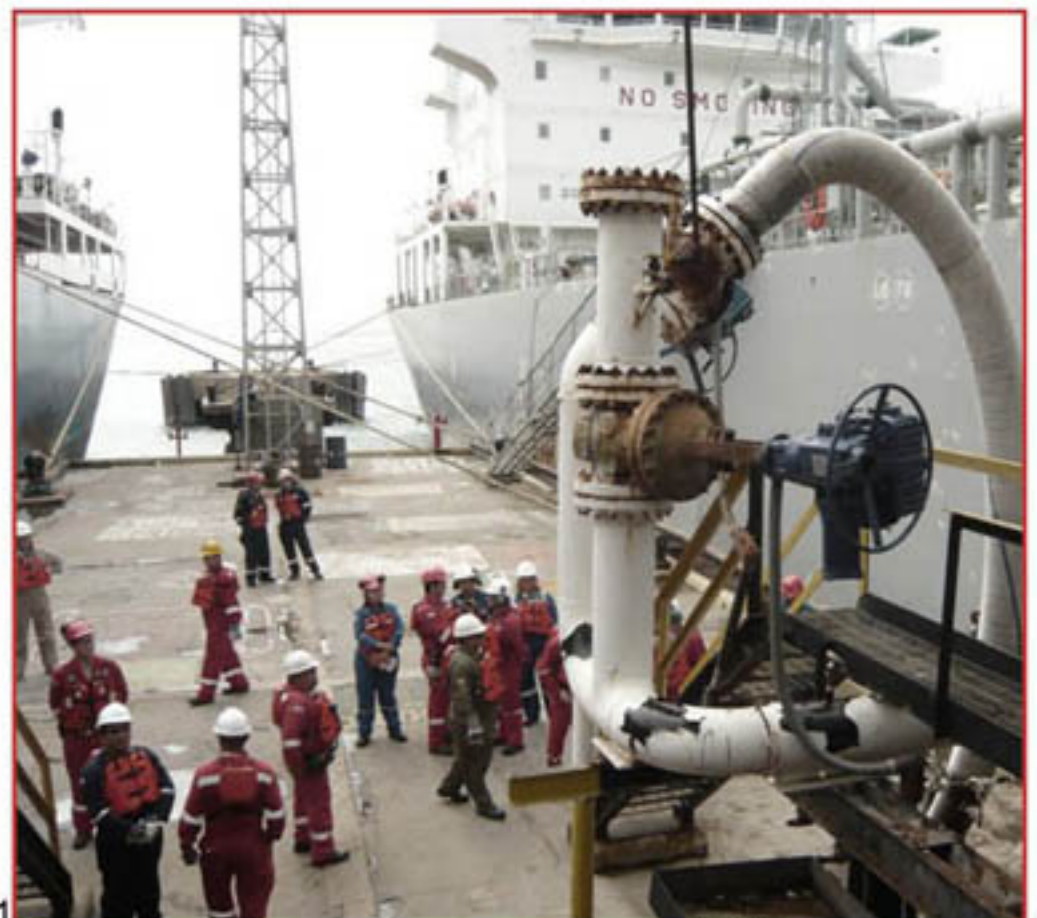
Hose handling Gantry – LPG hose (nearest) has not been supported by hoist. LPG line has motorised valve, locally operated.

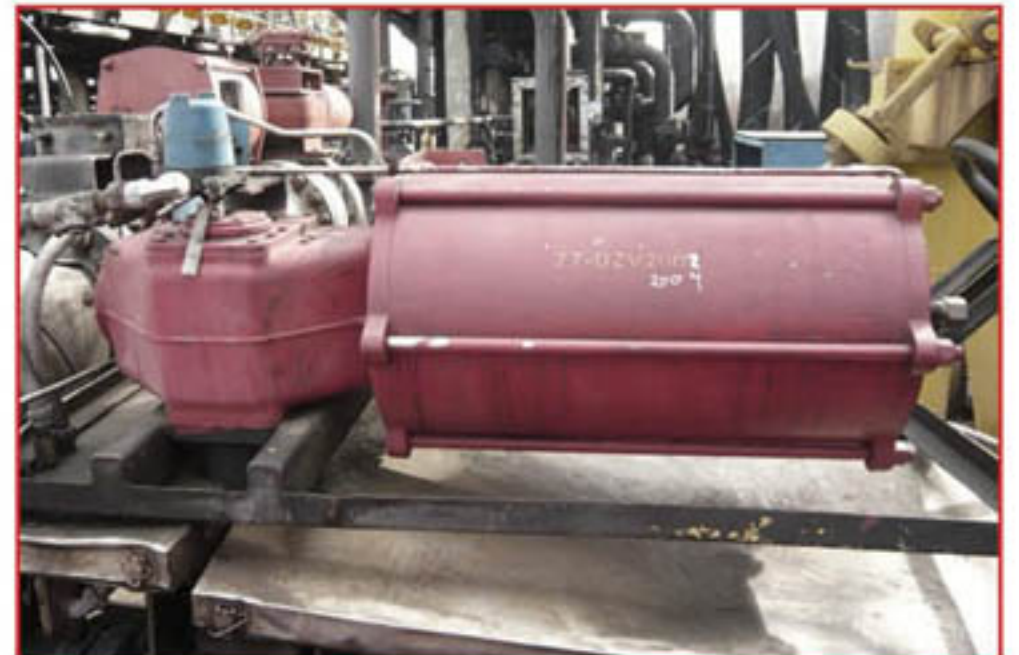
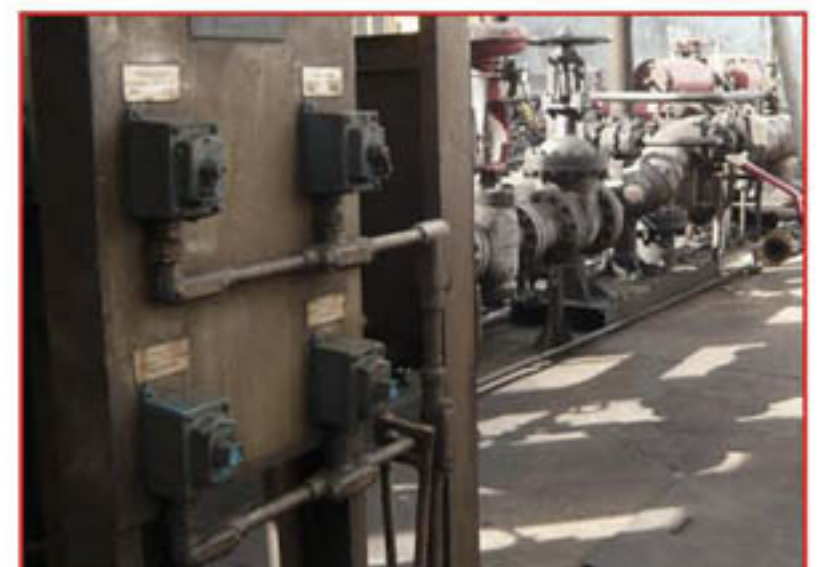
Emergency Isolation valve, failsafe, (air to open, spring to close) some confusion about tag nº, fireproof cover not replaced, actuation from local switch only.

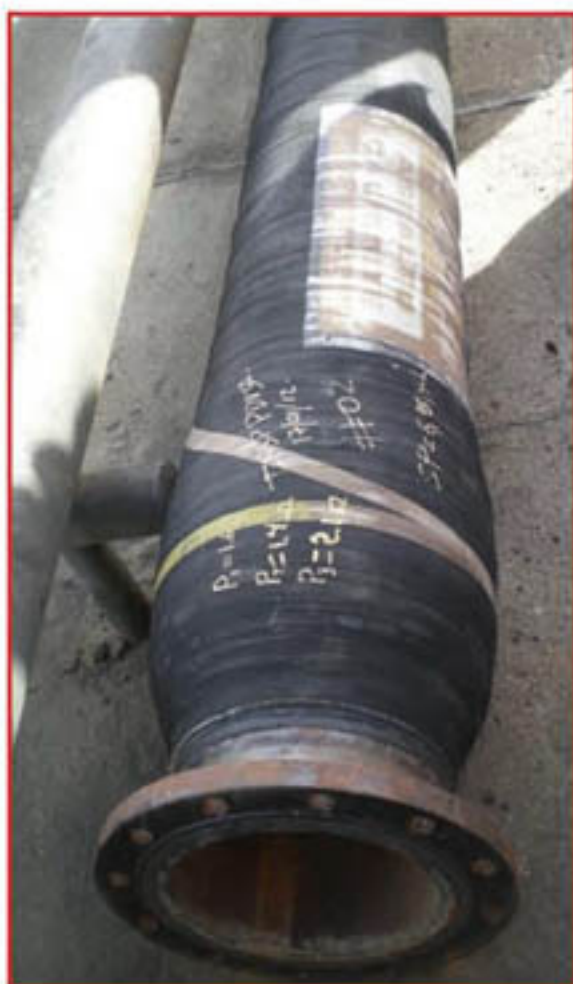
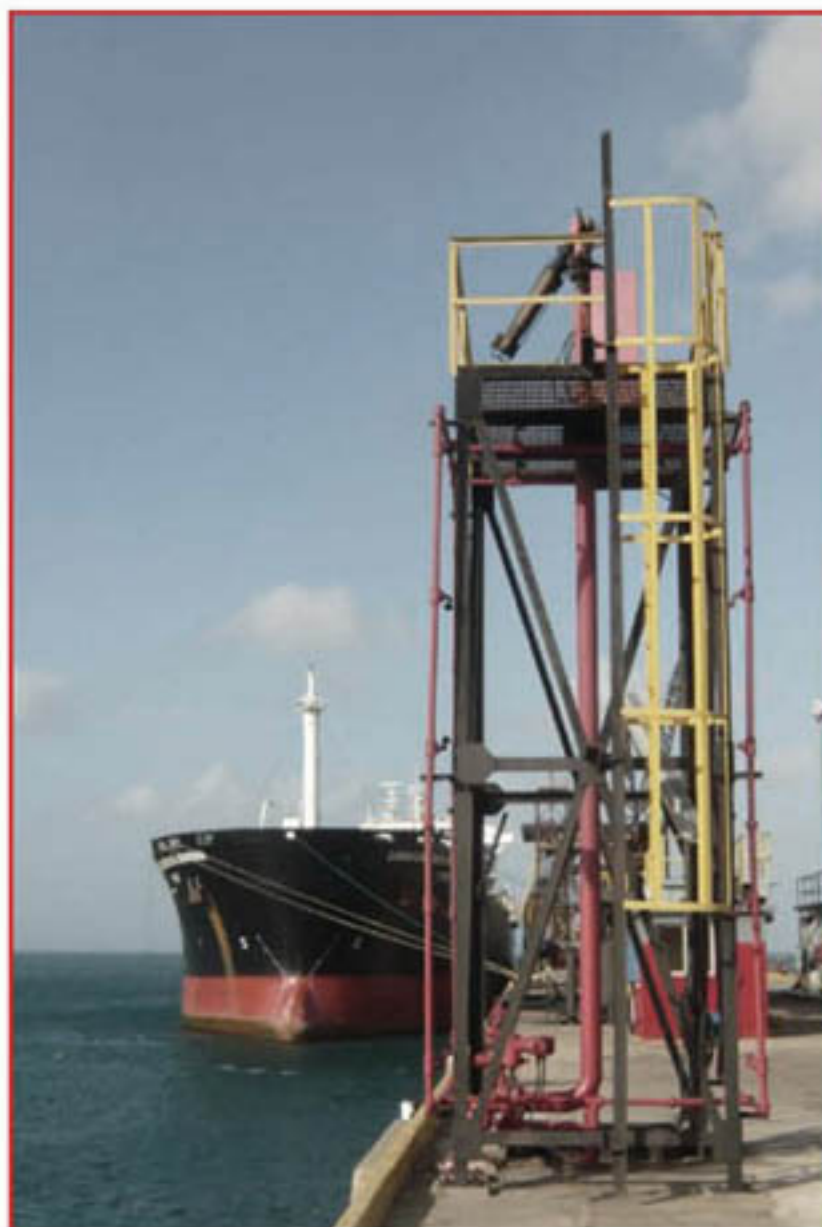
Hose with split outer vulcanised layer, and hose to replace it. (see test date on hose)

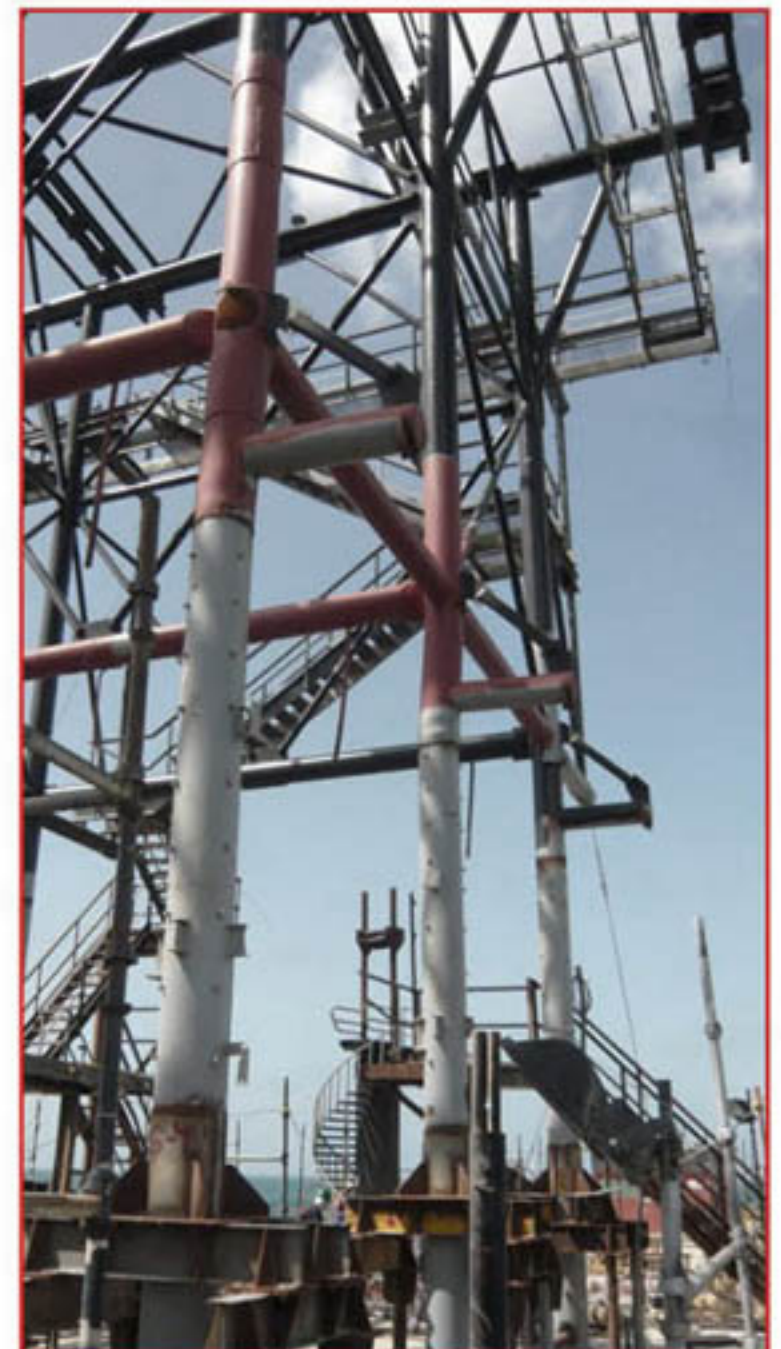
Temporary supports welded to original steel structure, resting on new concrete sub-structure while concrete replaced.
