Risk Improvement Recommendations Update Report

Centro de Refinación Paraguana
Estado Falcón
Venezuela

Recommendations Update Visit Made: March 5th-8th 2012
Prepared on behalf of

Ref.2012/139

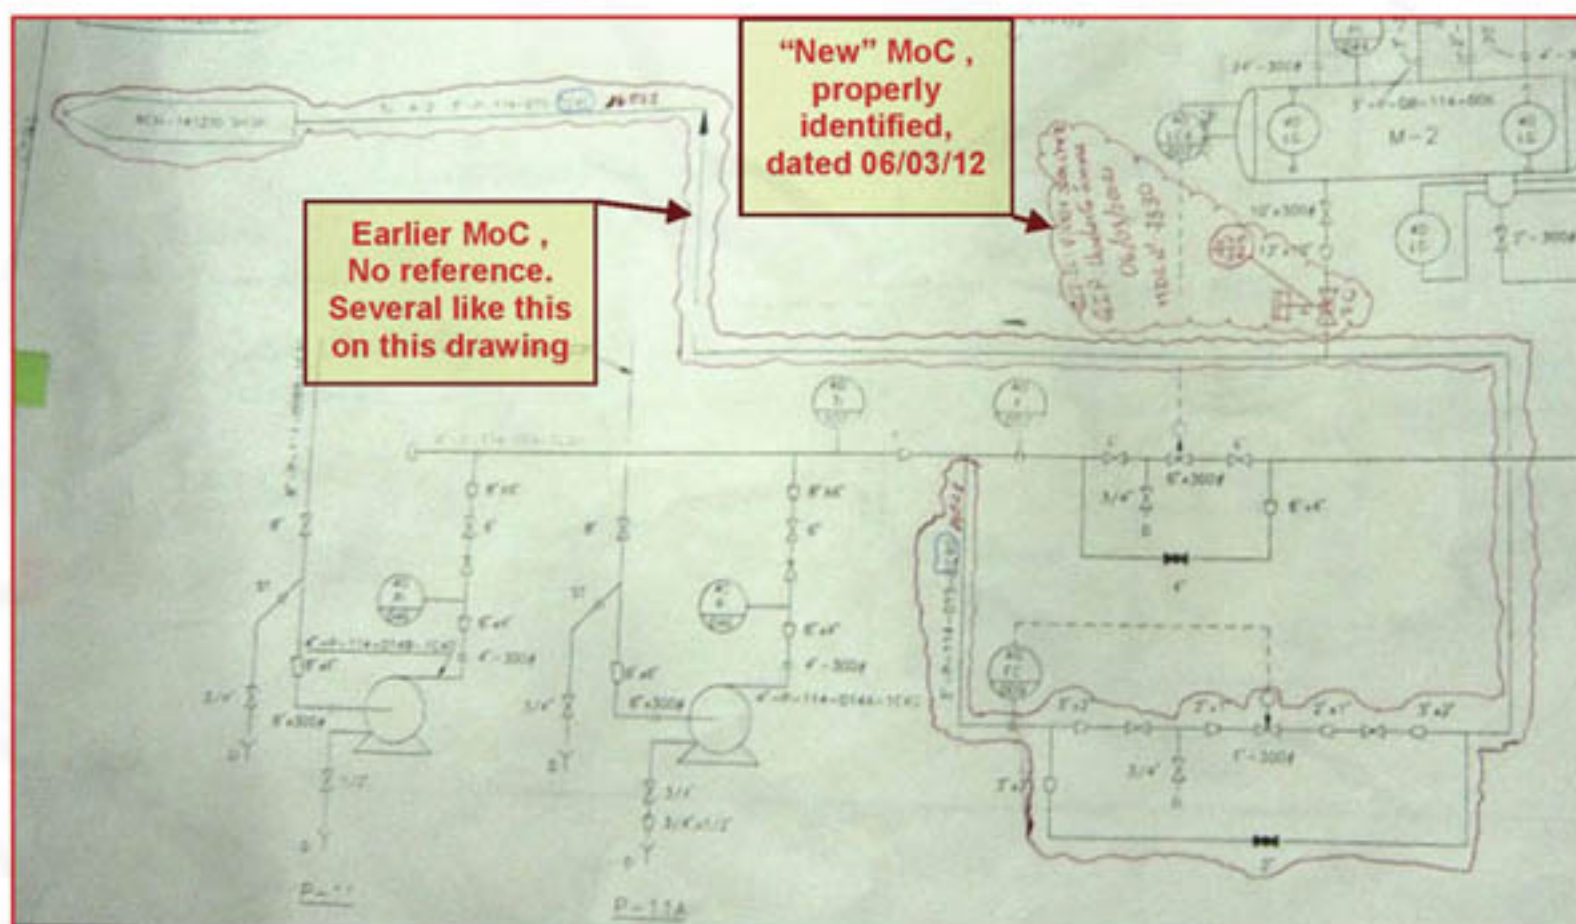
The so called "Master" copies of the P&IDs are kept as stick files in the control bunkers. "Actualisation" is said to be carried out, as part of the HazOp process, and this involves "walking the lines". About 80 are being done per year, and these are not being put into the control buildings until the HazOps are done. In our opinion, this is not logical – the "Master" drawings should be available for operational purposes. We noted few redline changes on the drawings we reviewed in the control buildings, and some of those we saw were confused, with the change "Clouds" not referenced to the authorisation or management of change number. There were also some changes that had been added very recently, for changes made in 2010, and the new EIVs redlines had been added during our visit. (See below)

The condition of some "master" drawings on stick-files was questionable (left), although we have been shown "actualised" drawings, properly approved (centre and right).

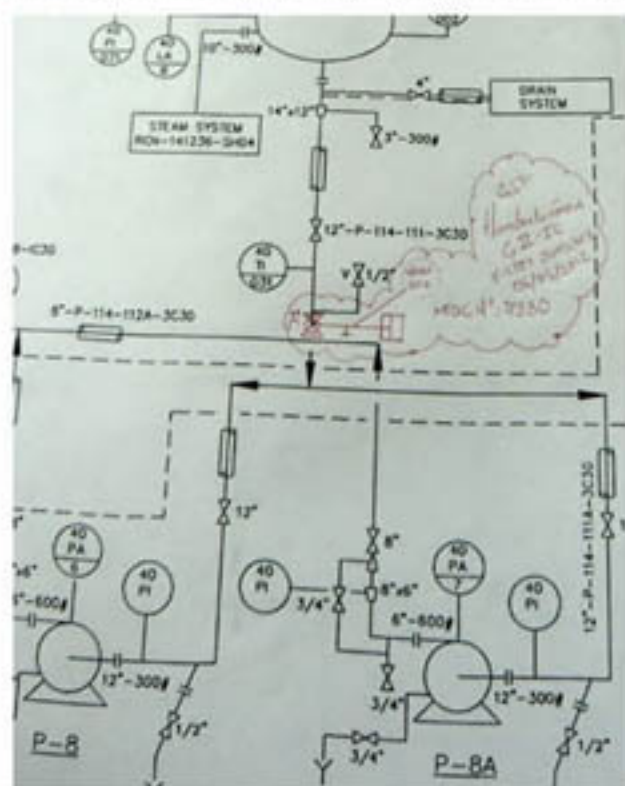
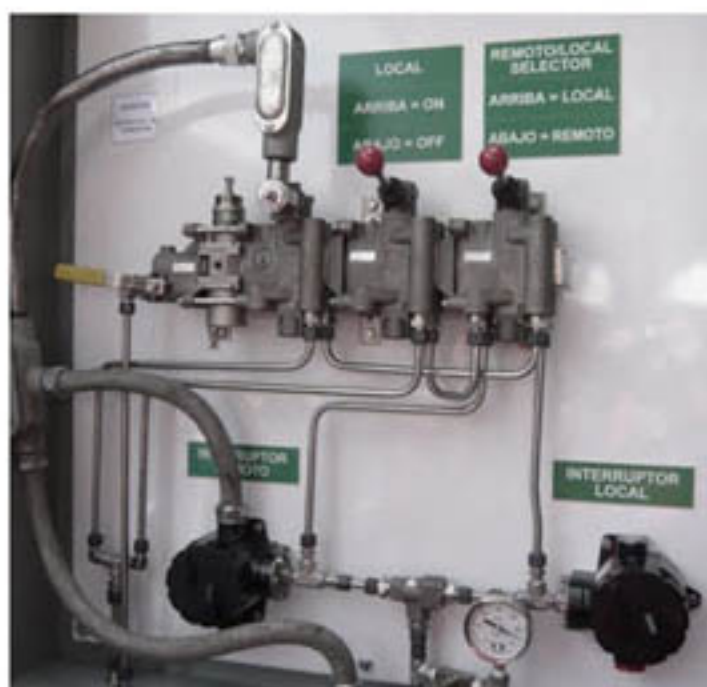
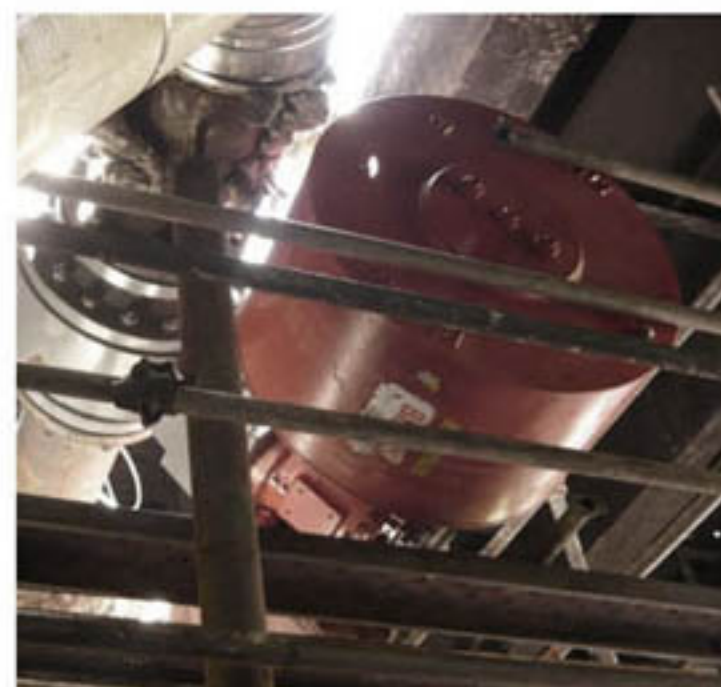
328 valves originally identified. Scope now reduced to 21, using PDVSA 1997 criteria of 25m³ inventory. Another ~20 will be needed. Scope now includes Overhead drum sour water draw valves. 5 valves installed at CD-4. Had this been implemented sooner, the consequences of the February 2012 CD4 fire would have been significantly reduced. (See pictures below). Legacy issues – Cardon EIVs are fail-safe pneumatic, those at Amuay are electrical drive.

1) Audit the units to identify all the inventories, connected to pumps with only manual isolation between the pump and the vessel, and with normal liquid levels over 5 m³ of LPG type material or 10m³ of other hydrocarbons Op. at temperature above, at or close to their flashpoint or auto-ignition temperature. For the systems meeting those criteria, install EIVs in the discharge lines of the vessels to the pumps. These valves should be installed as close as possible to the vessel or drum and be capable of being actuated from within the appropriate control room (see recommendation 05.11) and from a safe location within the process units. It is reminded too that the valves, actuator and cabling should have a fire rating of 20 minutes.

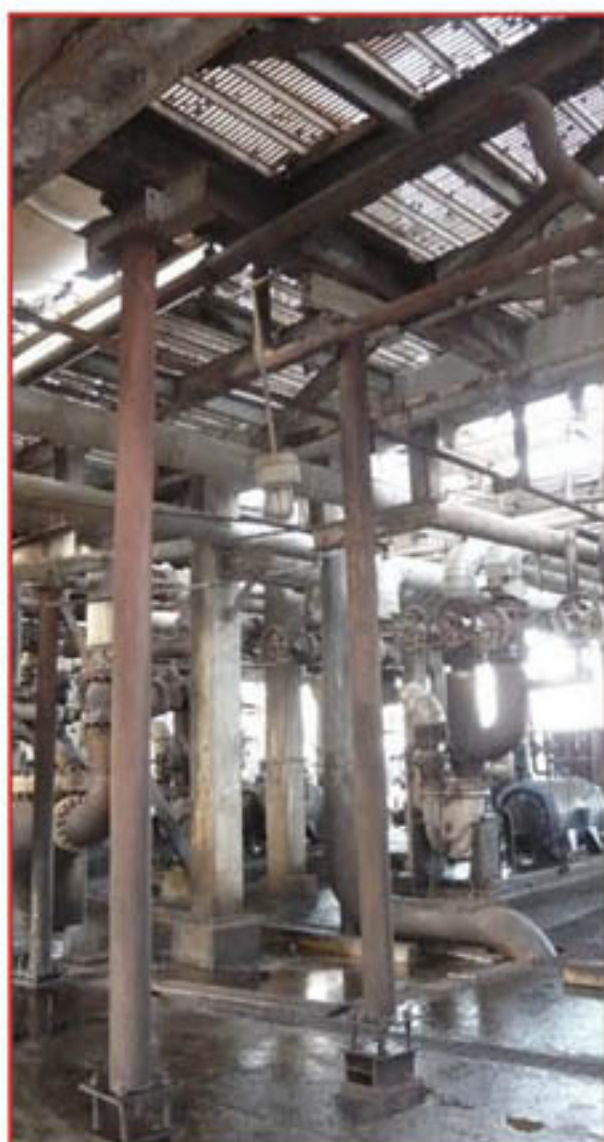
PVAY-4 Vacuum Unit, Compromised structural fire protection and temporary support in place pending repairs to structure.

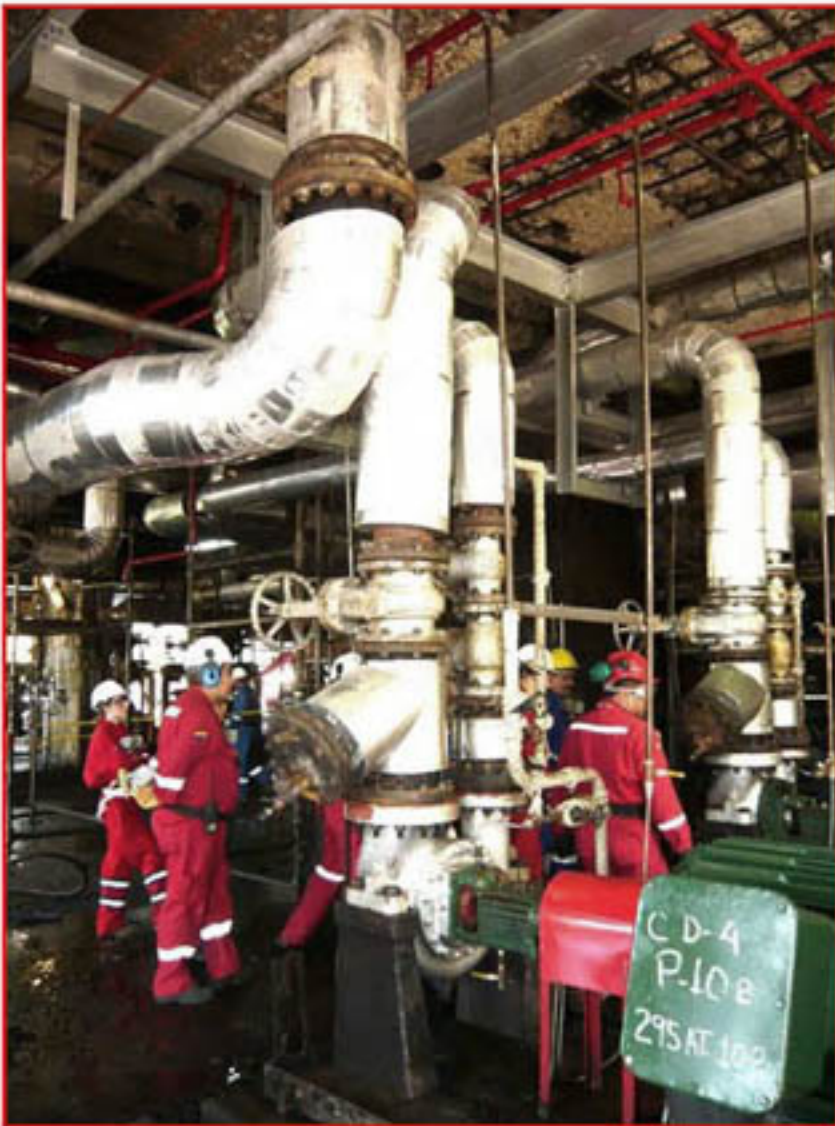
Cardón CD-4 Fire Repairs

Highly congested and confined area of pumps, re-bars exposed by concrete spalling on underside of upper (exchanger) deck, not clear when (if) these are to be repaired.

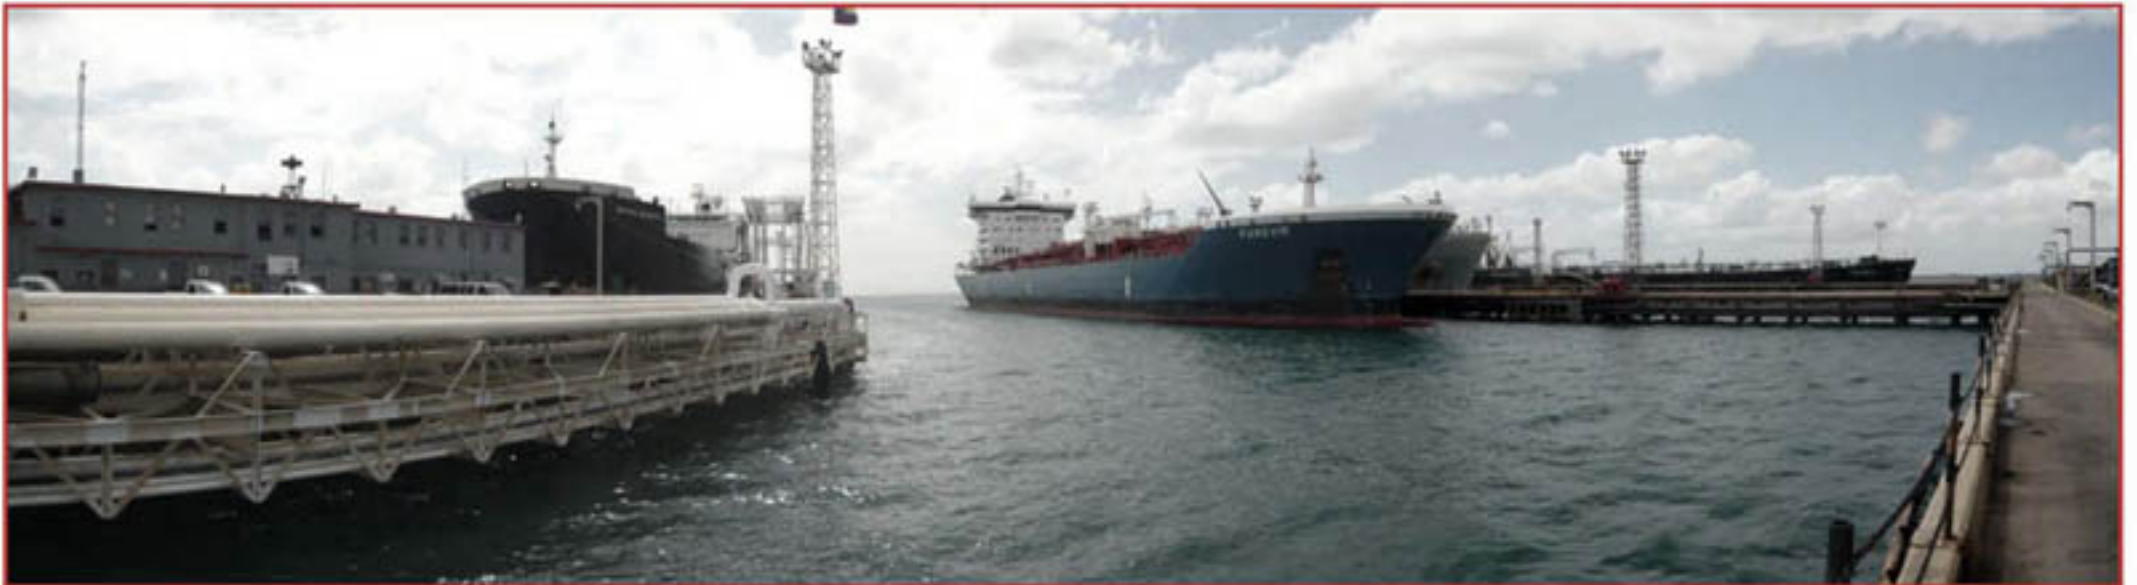
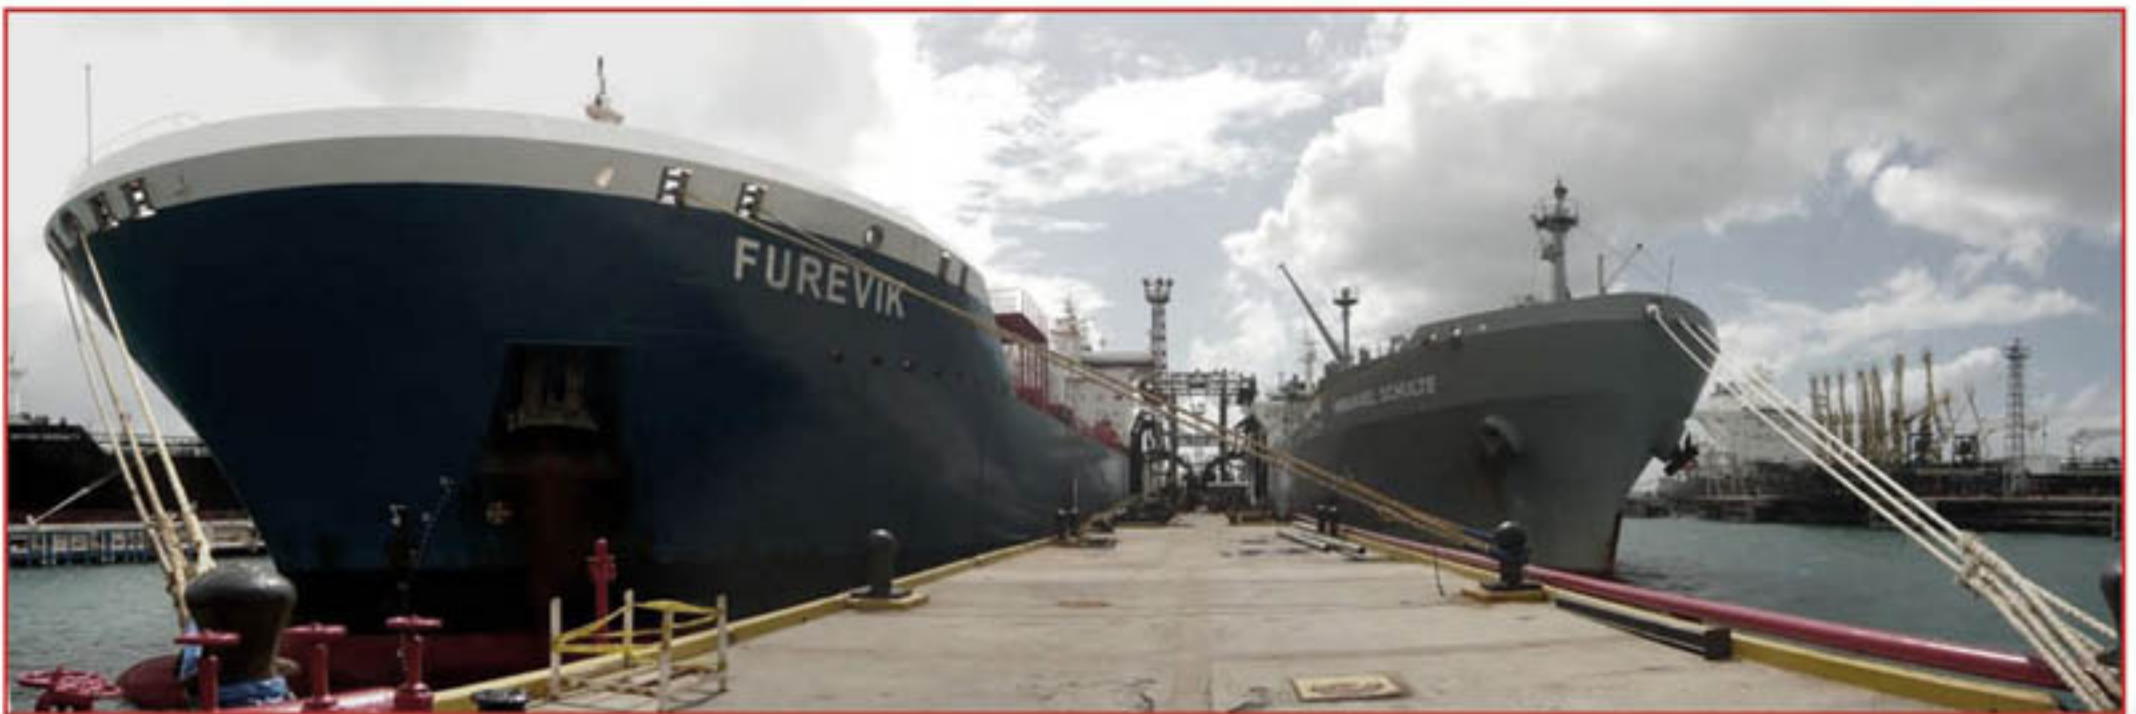
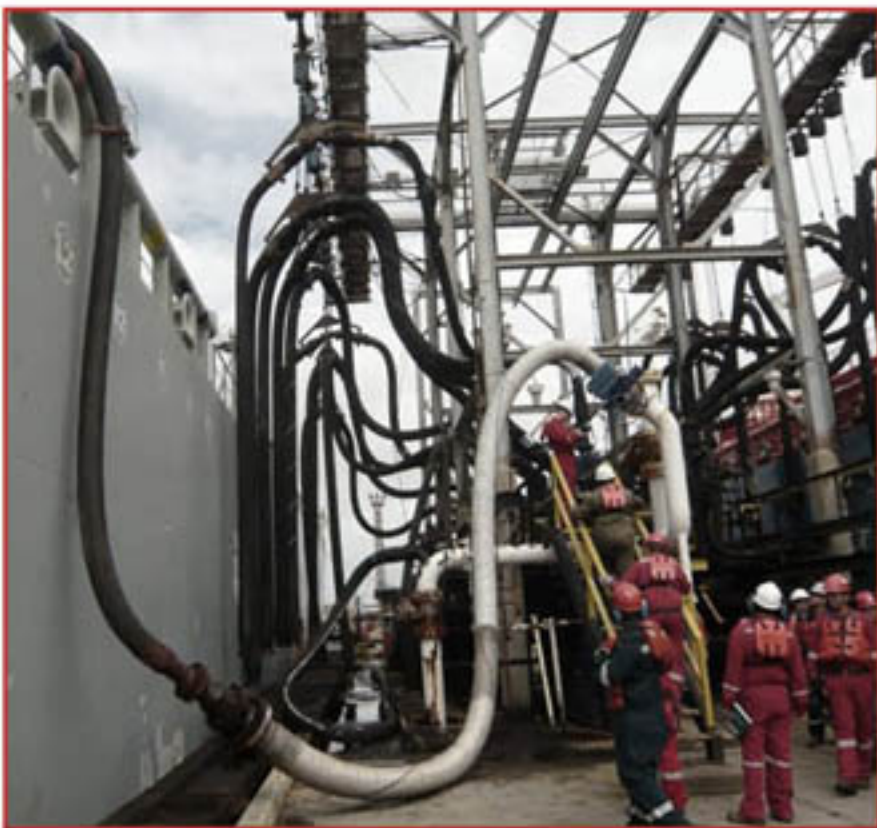
Amuay Jetties: Compact, Congested, incident on one likely to affect neighbour, in addition to the vessel on the adjacent berth.

Hose handling Gantry – LPG hose (nearest) has not been supported by hoist. LPG line has motorised valve, locally operated.

Relatively narrow jetty, ships close together.

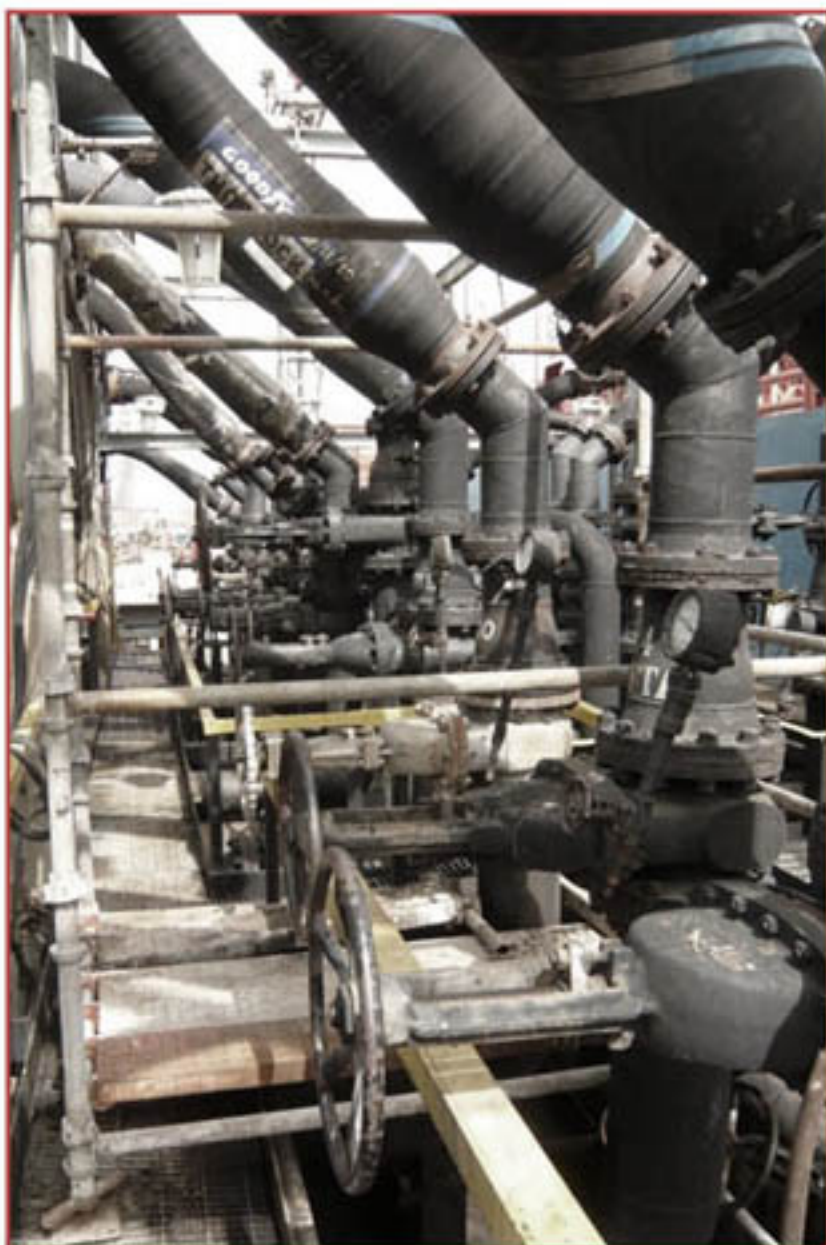
Manifold valves for most products are manual.

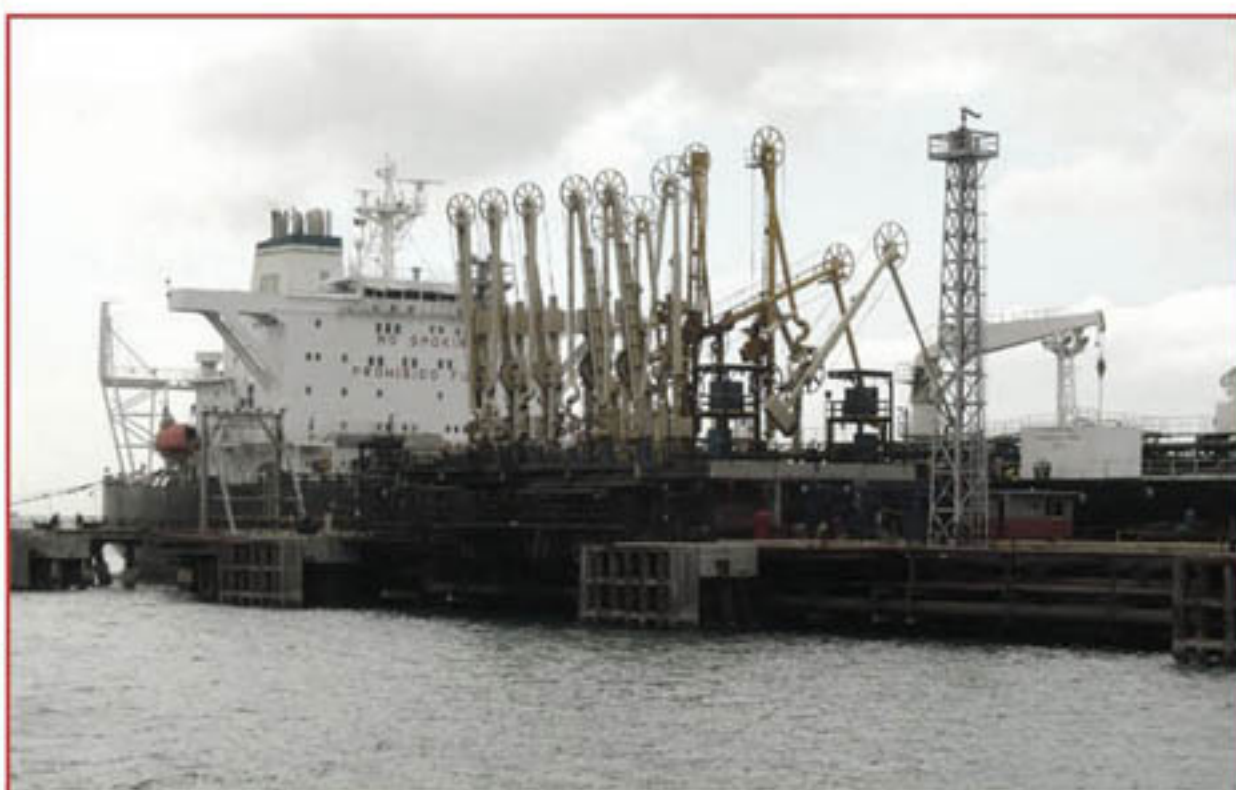
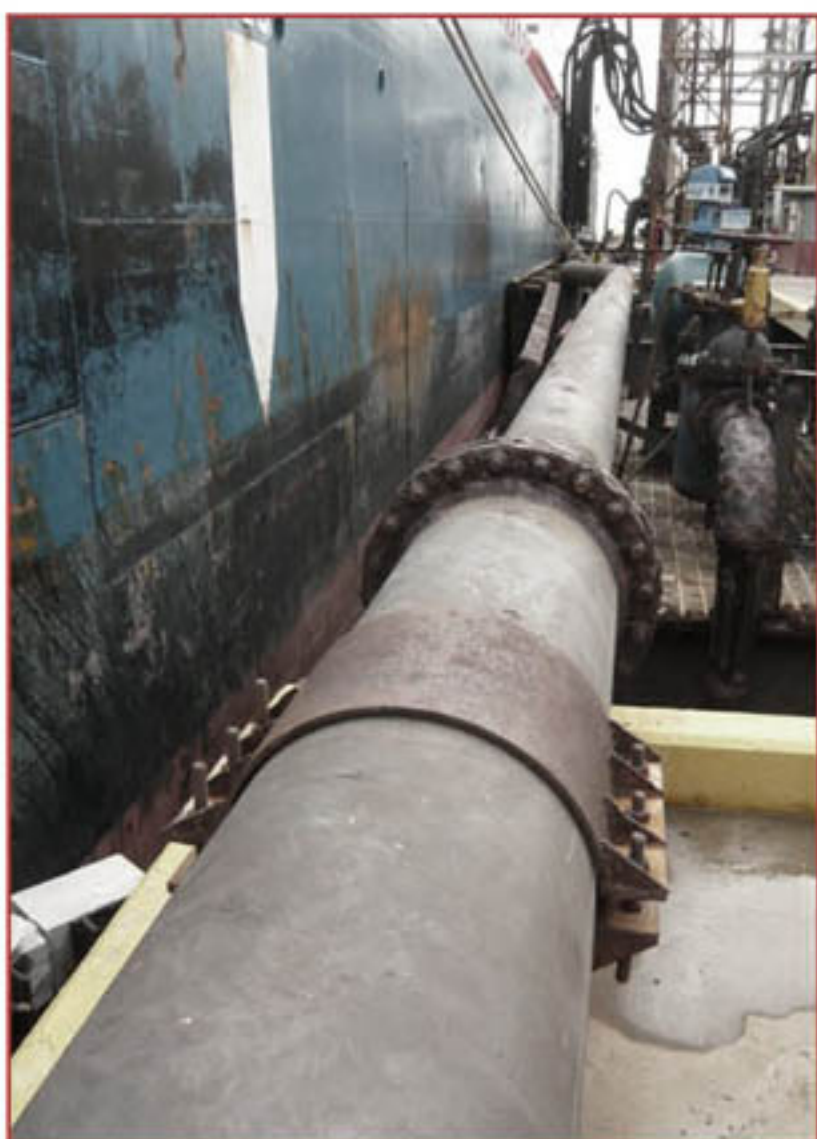
Adjacent jetty 4 has Chicksan Arms rather than hoses. Recently upgraded.

There are 2 clamps on the Kerosene line, to be eliminated at next TAM in 2013

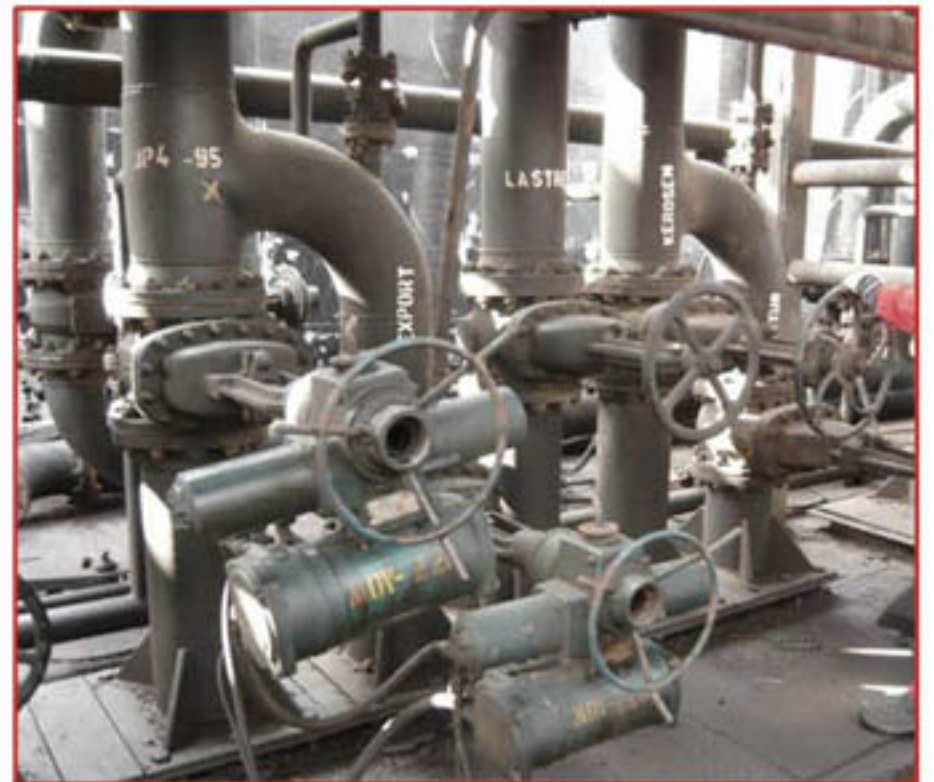
Complex manifold, some motorised valves, most manual.

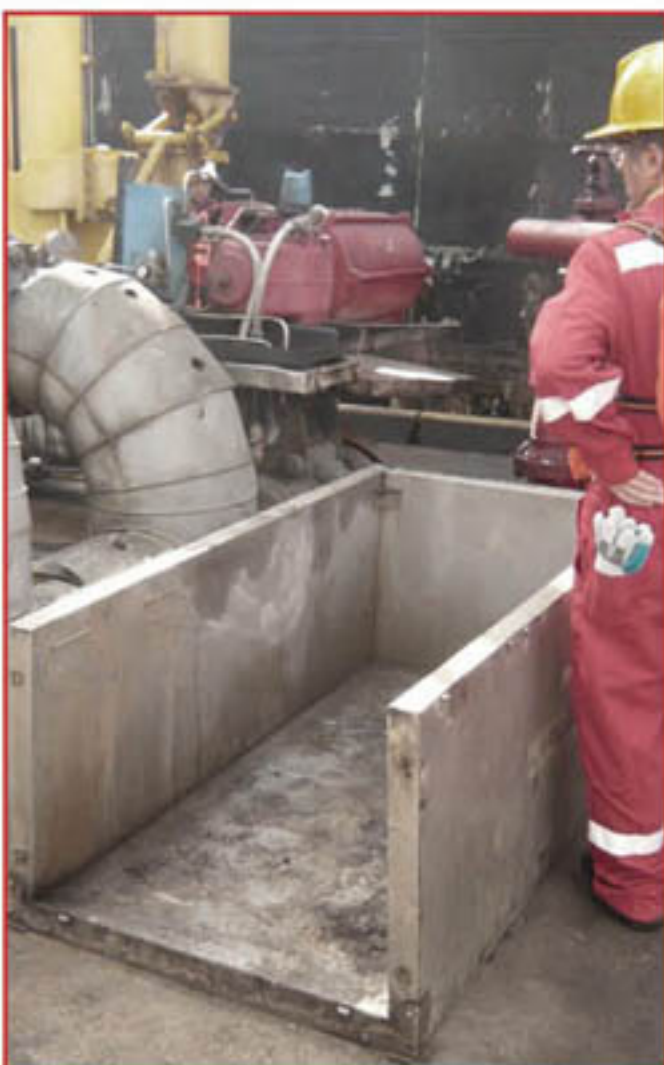
Emergency Isolation valve, failsafe, (air to open, spring to close) some confusion about tag nº, fireproof cover not replaced, actuation from local switch only.

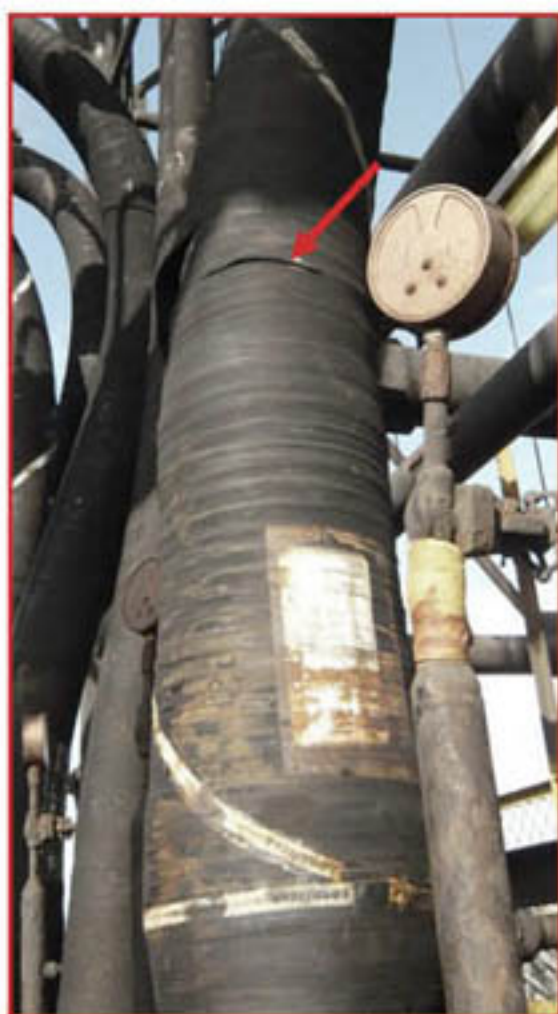
Hose with split outer vulcanised layer, and hose to replace it. (see test date on hose)

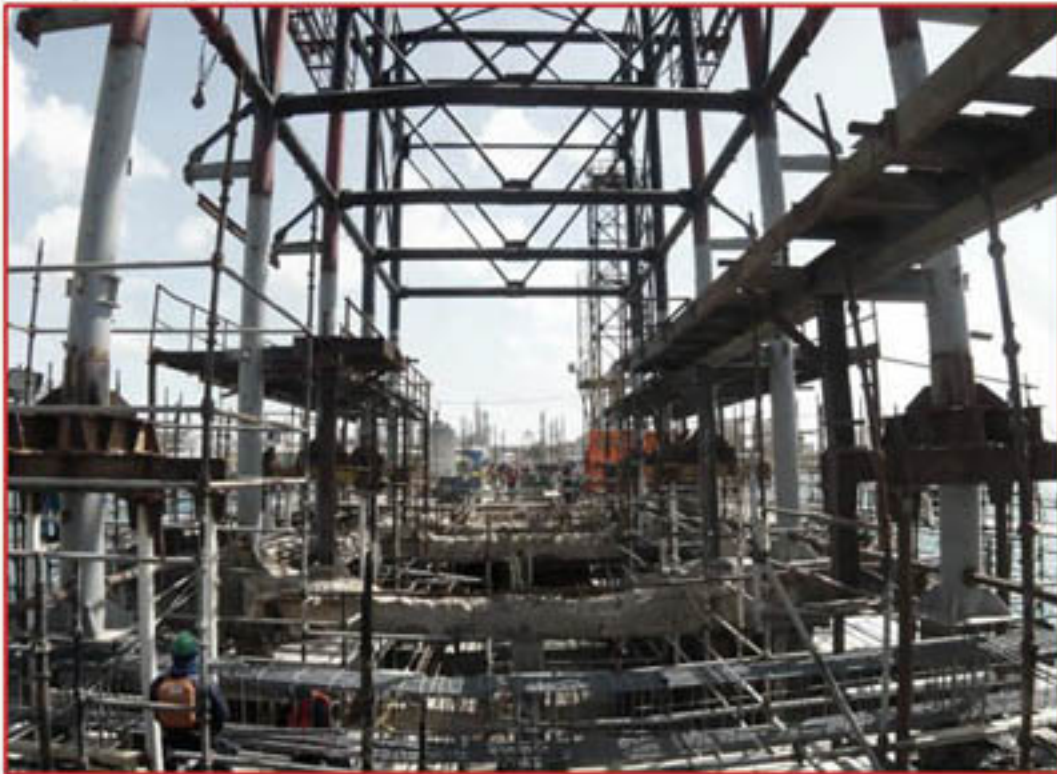
Jetty 1 Repairs

Under-deck structure extensively replaced

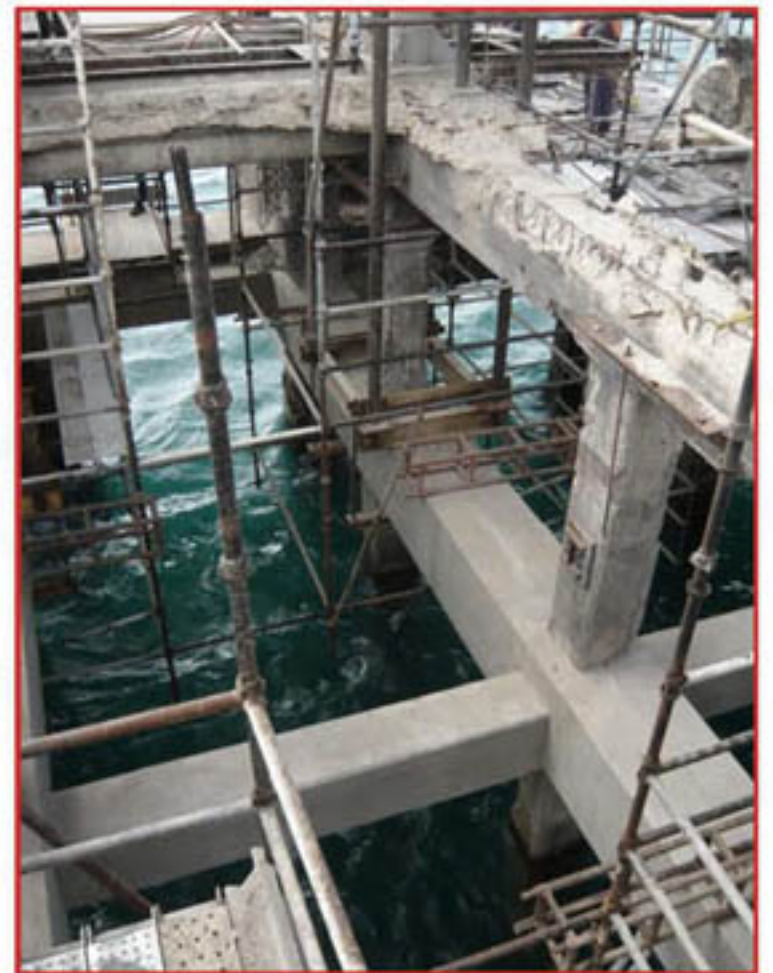
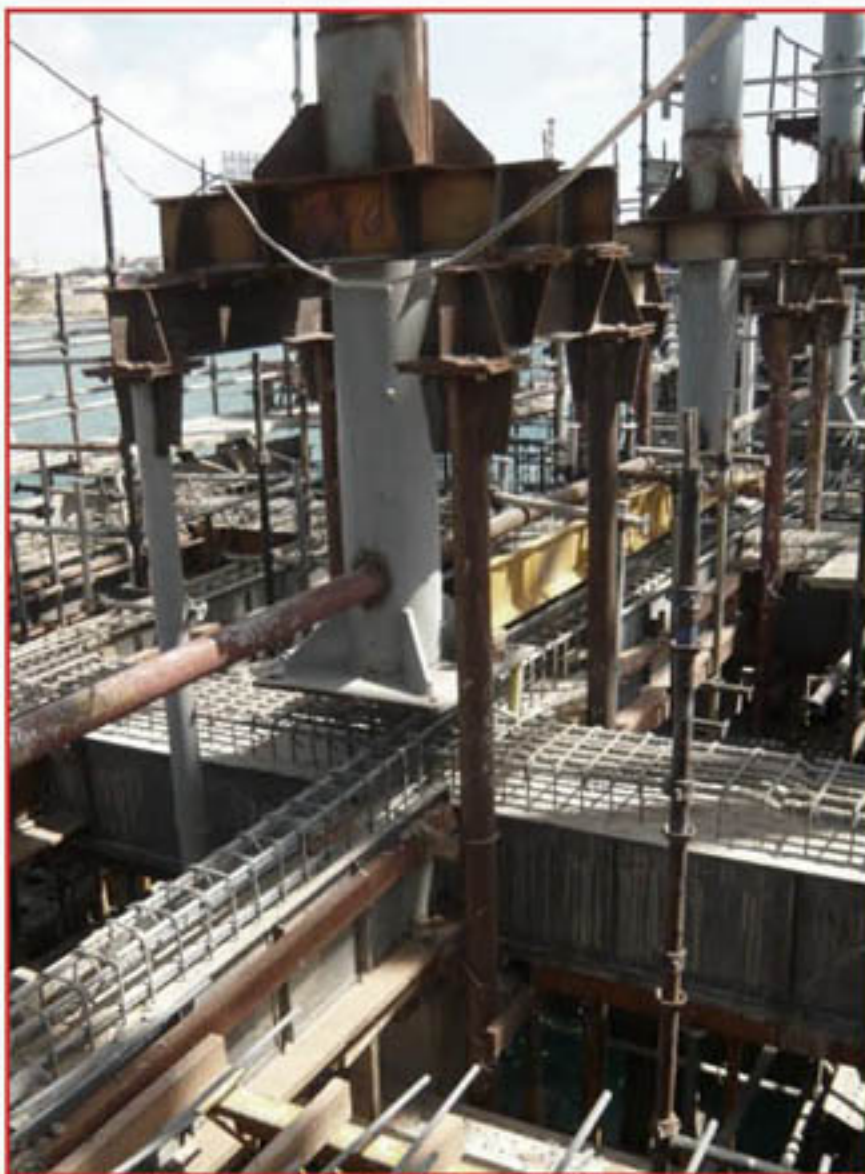
Temporary supports welded to original steel structure, resting on new concrete sub-structure while concrete replaced.
